Access Compliance Report

Public Rights-of-Way

(Curb Ramps)

Intersection ID: 48195	Main Street: BLAKENEY CENTRE DR	Cross Street: REA RD	Location: SE
ADA ID: 7CCFBA4029E2	Ramp Type: PerpDiag	Initial Pass/Fail: Fail	Overall Compliance: No
Severity Score: 33.75			
Codes/Mitigation Info/Possible Solution		Field Measurements/Component Compliance

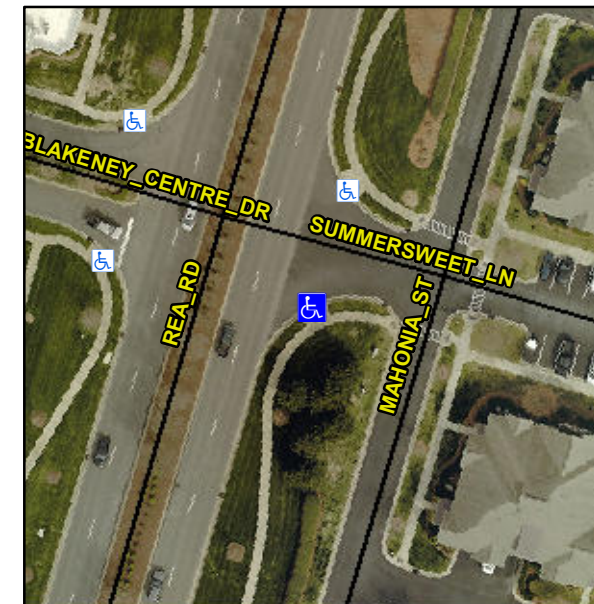
Compliance	Description	Data	Compliance	Description	Data
N/A	Ramp Length (in)	76.0	No	Ramp Slope (%)	13.6
No	Ramp Width (in)	42.0	Yes	Ramp XSlope (%)	1.4
N/A	Flare Type LT	N/A	N/A	Flare Type RT	N/A
N/A	Flare Slope LT (%)	N/A	N/A	Flare Slope RT (%)	N/A
N/A	Flare Traversable LT?	N/A	N/A	Flare Traversable RT?	N/A
N/A	Landing Length (in)	N/A	N/A	DWS Provided?	N/A
N/A	Landing Width (in)	N/A	N/A	DWS Contrast?	N/A
N/A	Landing Slope (%)	N/A	N/A	DWS Length (in)	N/A
N/A	Landing X Slope (%)	N/A	N/A	DWS Full Width?	N/A
N/A	Landing Curb? (Y/N)	N/A	N/A	DWS Offset (in)	N/A
N/A	Shared Landing?	N/A			
N/A	Gutter Ponding?	N/A	N/A	Gutter Slope (%)	N/A
N/A	Gutter Lip Ht (in)	N/A	N/A	Gutter X Slope (%)	N/A
N/A	Painted X Walk1?	No	N/A	Painted X Walk2?	No
	X Walk 1 Direction	To NE		X Walk 2 Direction	To NW
N/A	X Walk 1 Width (in)	N/A	N/A	X Walk 2 Width (in)	N/A
	X Walk 1 Slope (%)	1.9		X Walk 2 Slope (%)	4.0
	X Walk 1 X Slope (%)	2.8		X Walk 2 X Slope (%)	0.2

N/A	Ramp inside XWalk1?	N/A	N/A	Ramp inside XWalk2?	N/A
	Road Slope (%)	2.5	N/A	Clear Space?	N/A
	Road X Slope (%)	3.0	N/A	Clear Space to XWalk (in)	N/A
N/A	Any Obstructions?	N/A	N/A	Storm Grate/Utility Hazard?	N/A
	Obstruction Type			Storm Grate/Utility Type	
		N/A			N/A
			Yes	Surface Condition? (G/P)	Good

Remove & Replace Curb Ramp With Two New Directional Ramps or Equivalent.

R304.5.1, R304.2.2
