Access Compliance Report Public Rights-of-Way (Curb Ramps)

Intersection ID: 6349 Main Street: LAKEHILL RD **Cross Street: VALLEYDALE RD** Location: N **Overall Compliance: No Severity Score:** 10 ADA ID: 7CE361D7111D Ramp Type: Perp Initial Pass/Fail: Fail

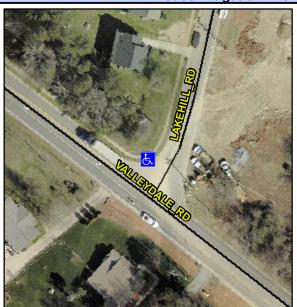
Compliance Description Data Compliance Description Data Yes N/A Ramp Length (in) 49.0 Ramp Slope (%) No Ramp XSlope (%) No Ramp Width (in) 47.0 N/A Flare Type LT N/A N/A Flare Type RT N/A N/A N/A Flare Slope RT (%) Flare Slope LT (%) N/A Flare Traversable LT? N/A N/A Flare Traversable RT? N/A N/A N/A **DWS Provided?** Landing Length (in) N/A Landing Width (in) N/A N/A **DWS Contrast?** N/A N/A N/A Landing Slope (%) DWS Length (in) N/A Landing X Slope (%) N/A N/A DWS Full Width? N/A Landing Curb? (Y/N) N/A N/A DWS Offset (in) N/A N/A Shared Landing? N/A **Gutter Ponding?** N/A N/A Gutter Slope (%) N/A Gutter Lip Ht (in) 0.5 N/A Gutter X Slope (%) N/A Painted X Walk1? No N/A Painted X Walk2? X Walk 1 Direction To S X Walk 2 Direction N/A N/A X Walk 1 Width (in) X Walk 2 Width (in) X Walk 1 Slope (%) 1.8 X Walk 2 Slope (%) X Walk 1 X Slope (%) 6.4 X Walk 2 X Slope (%) N/A N/A N/A Ramp inside XWalk2? Ramp inside XWalk1? Road Slope (%) 6.4 N/A Clear Space? N/A Road X Slope (%) Clear Space to XWalk (in) 1.8 N/A N/A Any Obstructions? N/A Storm Grate/Utility Hazard? **Obstruction Type** Storm Grate/Utility Type N/A

LAKEHILL RD Street 1 Name Stop Condition-Street 2 StopSign N/A Street 2 Name Stop Condition-Street 1 N/A Possible Solutions: Remove & Replace Entire Ramp. Surveyor Notes: N/A PROW/ADA: Not Found, R304.5.1, R304.5.3
