Access Compliance Report

Public Rights-of-Way

(Curb Ramps)

Intersection ID: 46237	Main Street: LINDEN_RIDGE_LN	Cross Street: MCINTYRE_AV	Location: NW
ADA ID: 7CE7035C9F07	Ramp Type: BlendTrans1	Initial Pass/Fail: Fail	Overall Compliance: No
			Severity Score: 21.25

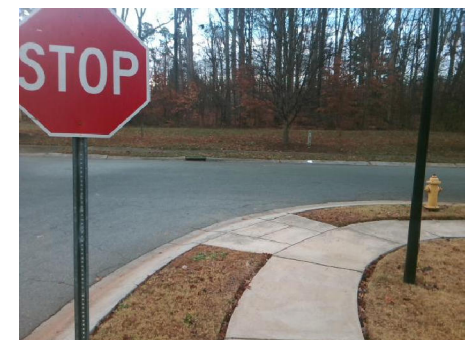
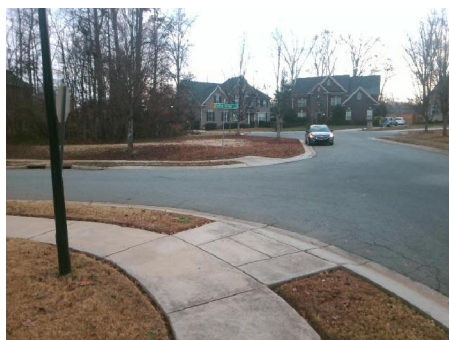
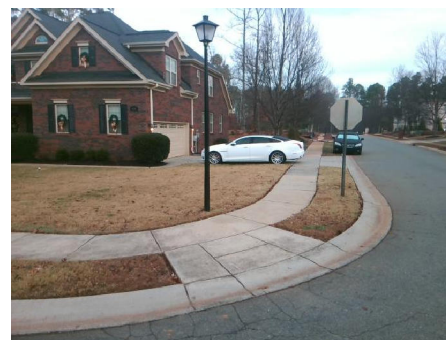
Not Found, R304.5.1, R304.5.3

Compliance	Description	Data	Compliance	Description	Data
N/A	Ramp Length (in)	50.0	Yes	BlendTrans Slope (%)	4.0
No	Ramp Width (in)	37.0	No	BlendTrans XSlope (%)	5.6
N/A	Flare Type LT	N/A	N/A	Flare Type RT	N/A
N/A	Flare Slope LT (%)	N/A	N/A	Flare Slope RT (%)	N/A
N/A	Flare Traversable LT?	N/A	N/A	Flare Traversable RT?	N/A
N/A	Landing Length (in)	N/A	N/A	DWS Provided?	N/A
N/A	Landing Width (in)	N/A	N/A	DWS Contrast?	N/A
N/A	Landing Slope (%)	N/A	N/A	DWS Length (in)	N/A
N/A	Landing X Slope (%)	N/A	N/A	DWS Full Width?	N/A
N/A	Landing Curb? (Y/N)	N/A	N/A	DWS Offset (in)	N/A
N/A	Shared Landing?	N/A			
N/A	Gutter Ponding?	N/A	N/A	Gutter Slope (%)	N/A
N/A	Gutter Lip Ht (in)	1.0	N/A	Gutter X Slope (%)	N/A
N/A	Painted X Walk1?	No	N/A	Painted X Walk2?	No
	X Walk 1 Direction	To S		X Walk 2 Direction	To E
	X Walk 1 Width (in)	N/A		X Walk 2 Width (in)	N/A
	X Walk 1 Slope (%)	2.5		X Walk 2 Slope (%)	3.5
	X Walk 1 X Slope (%)	3.4		X Walk 2 X Slope (%)	1.0

N/A	Ramp inside XWalk1?	N/A	N/A	Ramp inside XWalk2?	N/A
	Road Slope (%)	1.7		Clear Space?	N/A
	Road X Slope (%)	7.0	N/A	Clear Space to XWalk (in)	N/A
N/A	Any Obstructions?	N/A	N/A	Storm Grate/Utility Hazard?	N/A
	Obstruction Type			Storm Grate/Utility Type	
		N/A			N/A
			Yes	Surface Condition? (G/P)	Good
			No	Curb Slope (%)	6.7

Remove & Replace Curb Ramp With Two New Directional Ramps or Equivalent.
