# Access Compliance Report

## Public Rights-of-Way

### (Curb Ramps)

| Intersection ID: 52452 | Main Street: PAT_GARRETT_ST | Cross Street: BENDING_BIRCH_PL | Location: SW |

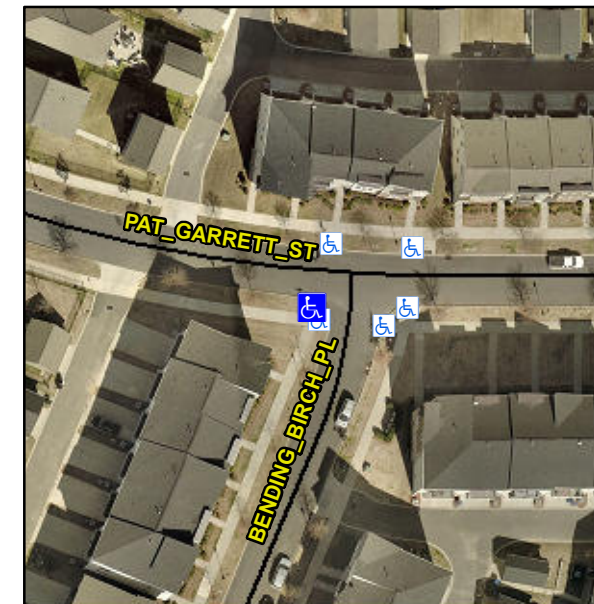
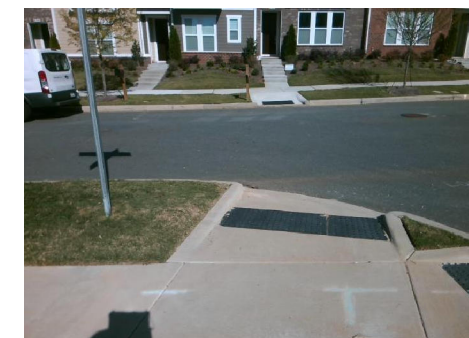
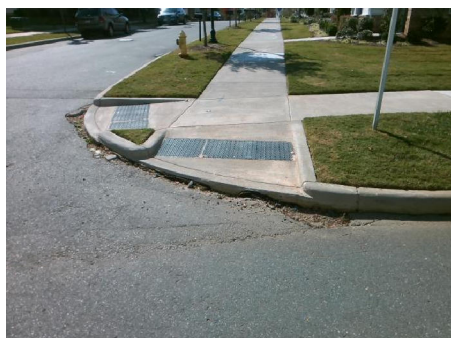
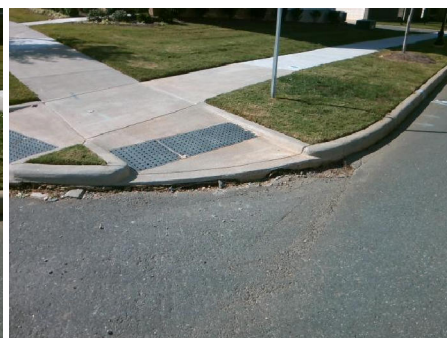
| ADA ID: 7CEA5994BC42 | Ramp Type: Directional1 | Initial Pass/Fail: Fail | Overall Compliance: No |
| Severity Score: 12.5 | | | |

**R304.2.2**

| Compliance | Description | Data | Compliance | Description | Data |
|---|---|---|---|---|---|
| No | Ramp Slope (%) | 8.8 | N/A | Grade Break XSlope (%) | 0.0 |

**Remove & Replace Entire Ramp.**

\$ 1600.00
