# Access Compliance Report

## Public Rights-of-Way

| Intersection ID: 19822 | Main Street: CHITAL_RD | Cross Street: THORNFIELD_RD | Location: SE |
| ADA ID: 7CEB9BE02B0C | Ramp Type: BlendTrans1 | Initial Pass/Fail: Pass | Overall Compliance: No |

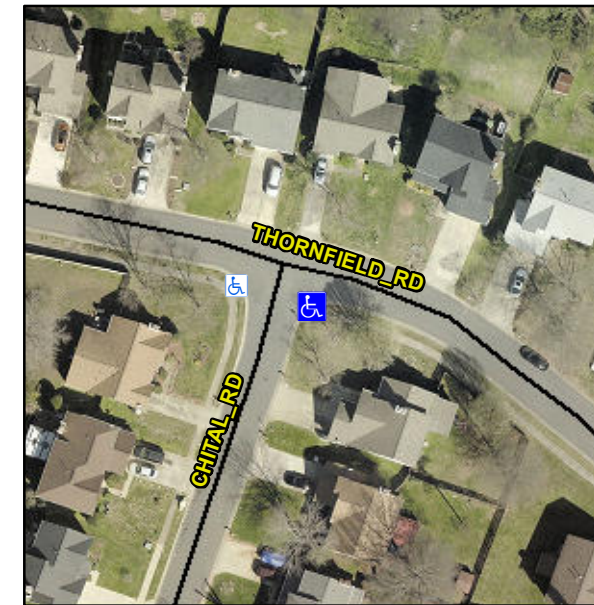
**Not Found, R304.2.1, R305**

| Compliance | Description | Data | Compliance | Description | Data |
|---|---|---|---|---|---|
| No | Landing Length (in) | 43.0 | No | DWS Provided? | No |
| | | | No | Curb Slope (%) | 15.1 |

**Remove & Replace Curb Ramp With Two New Directional Ramps or Equivalent.**
