## **Access Compliance Report Public Rights-of-Way** (Curb Ramps)

Cross Street: N/A Intersection ID: 10029210 Main Street: JOHN\_PRICE\_RD Location: NW Ramp Type: Directional1 **Overall Compliance: No ADA ID: 7CEC4787D27D** Initial Pass/Fail: Fail **Severity Score:** 1.25

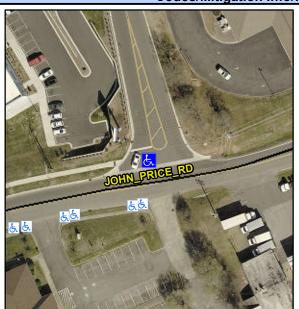
Field Measurements/Component Compliance							
Compli	ance Description	Data	Comp	liance Description	Data		
N/A	Ramp Length (in)	96.0	N/A	Grade Break?	N/A		
Yes	Ramp Width (in)	60.0	N/A	Grade Break Slope (%)	0.0		
Yes	Ramp Slope (%)	5.2	N/A	Grade Break XSlope (%)	0.0		
No	Ramp XSlope (%)	2.1					
N/A	Flare Type LT	N/A	N/A	Flare Type RT	N/A		
N/A	Flare Slope LT (%)	N/A	N/A	Flare Slope RT (%)	0.0		
N/A	Flare Traversable LT?	N/A	N/A	Flare Traversable RT?	N/A		
N/A	Landing Length (in)	0.0	N/A	DWS Provided?	N/A		
N/A	Landing Width (in)	0.0	N/A	DWS Contrast?	N/A		
N/A	Landing Slope (%)	0.0	N/A	DWS Length (in)	N/A		
N/A	Landing X Slope (%)	0.0	N/A	DWS Full Width?	N/A		
N/A	Landing Curb? (Y/N)	N/A	N/A	DWS Offset LT (in)	N/A		
N/A	Shared Landing?	N/A	N/A	DWS Offset RT (in)	N/A		
N/A	Gutter Ponding?	0.0	N/A	Gutter Slope (%)	N/A		
N/A	Gutter Lip Ht (in)	0.0	N/A	Gutter X Slope (%)	N/A		
N/A	Painted X Walk1?	No		Road Slope (%)	0.9

X Walk 1 Direction	To NE		Road X Slope (%)	2.1		
	X Walk 1 Width (in)	N/A		Clear Space?	N/A		
	X Walk 1 Slope (%)	0.9	N/A	Clear Space to XWalk (in)	N/A		
	X Walk 1 X Slope (%)	2.1	N/A	Storm Grate/Utility Hazard?	N/A		
N/A	Ramp inside XWalk1?	N/A		Storm Grate/Utility Type			
N/A	Any Obstructions?	N/A			N/A		
	Obstruction Type		Yes	Surface Condition? (G/P)	Good		
		N/A	N/A	Curb Slope (%)	3.7

V	Possible Solutions:
	Remove & Replace Entire Ramp.
The state of the s	Surveyor Notes:
The state of the s	PROW/ADA: R304.5.3
The state of the s
