Access Compliance Report

Public Rights-of-Way

(Curb Ramps)

Intersection ID: 50042	Main Street: BAXTER_ST	Cross Street: S_KINGS_DR	Location: SE
ADA ID: 7CF33DD9A6B8	Ramp Type: Perp	Initial Pass/Fail: Fail	Overall Compliance: No
Severity Score: 33.75			
Codes/Mitigation Info/Possible Solution		Field Measurements/Component Compliance

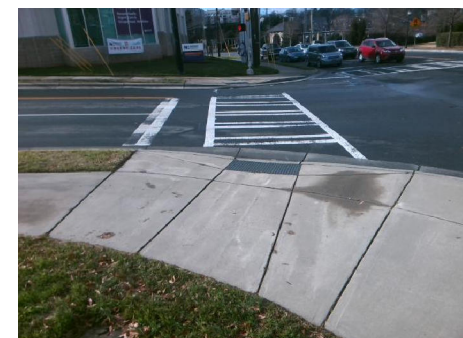
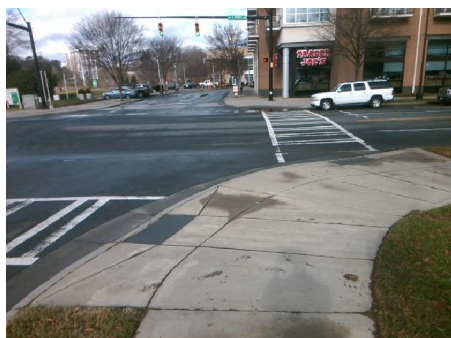
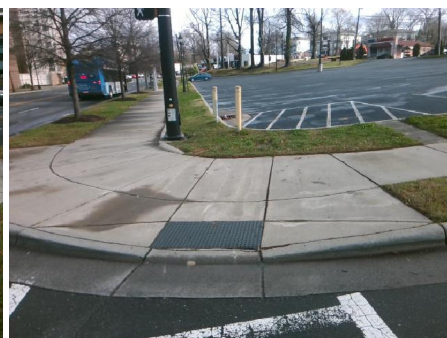
Compliance	Description	Data	Compliance	Description	Data
N/A	Ramp Length (in)	133.0	Yes	Ramp Slope (%)	7.1
No	Ramp Width (in)	47.0	No	Ramp XSlope (%)	8.0
N/A	Flare Type LT	N/A	N/A	Flare Type RT	N/A
N/A	Flare Slope LT (%)	N/A	N/A	Flare Slope RT (%)	N/A
N/A	Flare Traversable LT?	N/A	N/A	Flare Traversable RT?	N/A
N/A	Landing Length (in)	N/A	N/A	DWS Provided?	N/A
N/A	Landing Width (in)	N/A	N/A	DWS Contrast?	N/A
N/A	Landing Slope (%)	N/A	N/A	DWS Length (in)	N/A
N/A	Landing X Slope (%)	N/A	N/A	DWS Full Width?	N/A
N/A	Landing Curb? (Y/N)	N/A	N/A	DWS Offset (in)	N/A
N/A	Shared Landing?	N/A			
N/A	Gutter Ponding?	N/A	N/A	Gutter Slope (%)	N/A
N/A	Gutter Lip Ht (in)	N/A	N/A	Gutter X Slope (%)	N/A
N/A	Painted X Walk1?	Yes	N/A	Painted X Walk2?	N/A
	X Walk 1 Direction	To SW		X Walk 2 Direction	N/A
N/A	X Walk 1 Width (in)	104.0	N/A	X Walk 2 Width (in)	N/A
	X Walk 1 Slope (%)	0.9		X Walk 2 Slope (%)	N/A
	X Walk 1 X Slope (%)	4.8		X Walk 2 X Slope (%)	N/A

N/A	Ramp inside XWalk1?	Yes	N/A	Ramp inside XWalk2?	N/A
	Road Slope (%)	N/A	N/A	Clear Space?	N/A
	Road X Slope (%)	N/A	N/A	Clear Space to XWalk (in)	N/A
N/A	Any Obstructions?	N/A	N/A	Storm Grate/Utility Hazard?	N/A
	Obstruction Type			Storm Grate/Utility Type	
		N/A			N/A
		Yes		Surface Condition? (G/P)	Good

Possible Solutions:

Remove & Replace Entire Ramp.

R304.5.1, R304.5.3
