Access Compliance Report

Public Rights-of-Way

(Curb Ramps)

Intersection ID: 13002	Main Street: CENTRAL_AV	Cross Street: PIEDMONT_ST	Location: NW
ADA ID: 7CF86A2B1FBB	Ramp Type: BlendTrans1	Initial Pass/Fail: Pass	Overall Compliance: No
Severity Score: 17.5			
Codes/Mitigation Info/Possible Solution		Field Measurements/Component Compliance

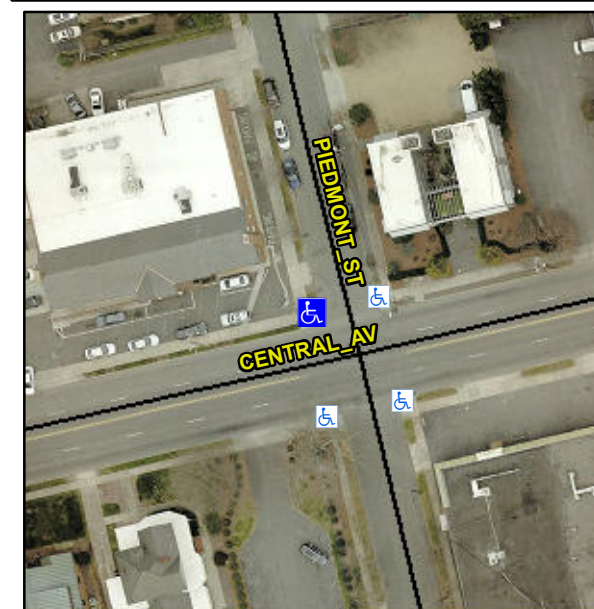
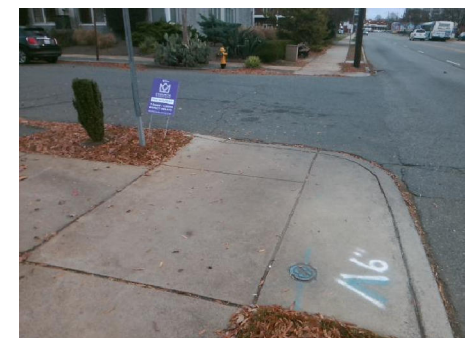
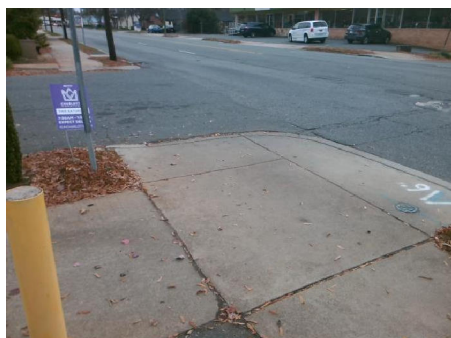
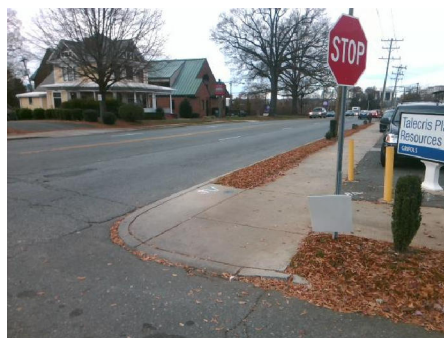
Not Found, R305, R302.7, R302.7.2

Compliance	Description	Data	Compliance	Description	Data
N/A	Ramp Length (in)	47.0	Yes	BlendTrans Slope (%)	1.2
Yes	Ramp Width (in)	58.0	Yes	BlendTrans XSlope (%)	0.3
N/A	Flare Type LT	Sloped	N/A	Flare Type RT	Sloped
N/A	Flare Slope LT (%)	1.3	N/A	Flare Slope RT (%)	9.9
N/A	Flare Traversable LT?	No	N/A	Flare Traversable RT?	No
Yes	Landing Length (in)	83.0	No	DWS Provided?	No
Yes	Landing Width (in)	71.0	N/A	DWS Contrast?	No
Yes	Landing Slope (%)	0.8	N/A	DWS Length (in)	N/A
Yes	Landing X Slope (%)	0.9	N/A	DWS Full Width?	No
N/A	Landing Curb? (Y/N)	No	N/A	DWS Offset (in)	N/A
N/A	Shared Landing?	Yes			
No	Gutter Ponding?	Yes	Yes	Gutter Slope (%)	2.8
No	Gutter Lip Ht (in)	0.5	Yes	Gutter X Slope (%)	0.6
N/A	Painted X Walk1?	No	N/A	Painted X Walk2?	N/A
	X Walk 1 Direction	To E		X Walk 2 Direction	N/A
	X Walk 1 Width (in)	N/A		X Walk 2 Width (in)	N/A
	X Walk 1 Slope (%)	5.6		X Walk 2 Slope (%)	N/A
	X Walk 1 X Slope (%)	1.2		X Walk 2 X Slope (%)	N/A

N/A	Ramp inside XWalk1?	N/A	N/A	Ramp inside XWalk2?	N/A
	Road Slope (%)	1.2		Clear Space?	Yes
	Road X Slope (%)	5.6	N/A	Clear Space to XWalk (in)	N/A
Yes	Any Obstructions?	No	Yes	Storm Grate/Utility Hazard?	No
	Obstruction Type			Storm Grate/Utility Type	
		N/A			N/A
			Yes	Surface Condition? (G/P)	Good
			No	Curb Slope (%)	11.2

Possible Solutions:

Remove & Replace Curb Ramp With Two New Directional Ramps or Equivalent.
