Access Compliance Report

Public Rights-of-Way

(Curb Ramps)

Intersection ID: 28112	Main Street: PROVIDENCE_RD	Cross Street: BELICOURT_DR	Location: SW
ADA ID: 7D0A92E891C9	Ramp Type: Para	Initial Pass/Fail: Fail	Overall Compliance: No
Severity Score: 13.75			
Codes/Mitigation Info/Possible Solution		Field Measurements/Component Compliance

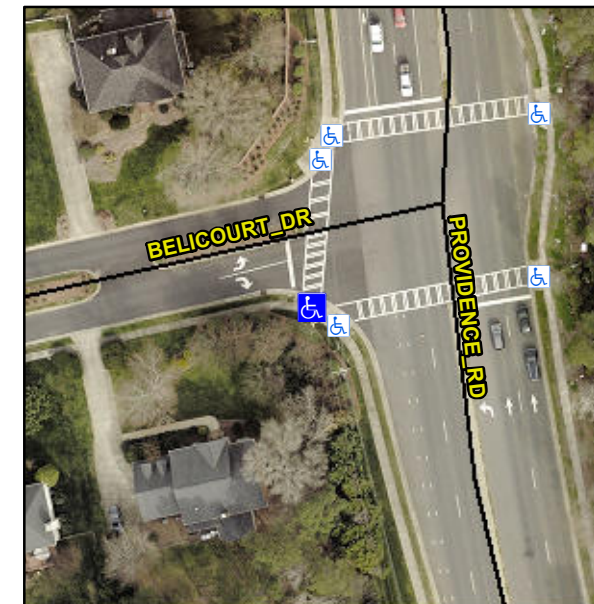
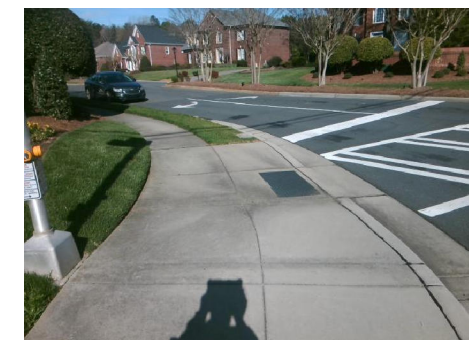
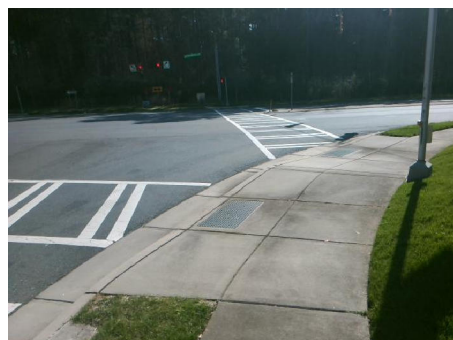
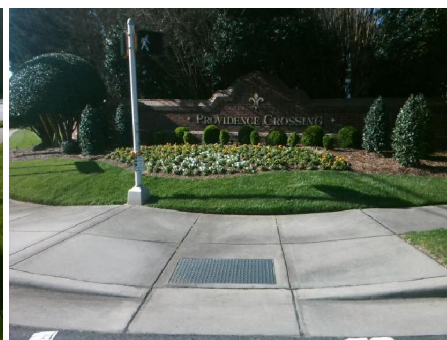
LT RP < 5%

Compliance	Description	Data	Compliance	Description	Data
N/A	Ramp Length LT (in)	55.0	N/A	Ramp Length RT (in)	58.0
Yes	Ramp Width LT (in)	57.0	Yes	Ramp Width RT (in)	50.0
Yes	Ramp Slope LT (%)	4.9	No	Ramp Slope RT (%)	10.5
No	Ramp XSlope LT (%)	3.1	No	Ramp XSlope RT (%)	2.1
N/A	Landing Length (in)	N/A	N/A	DWS Provided?	N/A
N/A	Landing Width (in)	N/A	N/A	DWS Contrast?	N/A
N/A	Landing Slope (%)	N/A	N/A	DWS Length (in)	N/A
N/A	Landing X Slope (%)	N/A	N/A	DWS Full Width?	N/A
N/A	Landing Curb? (Y/N)	N/A	N/A	DWS Offset (in)	N/A
N/A	Shared Landing?	N/A			
N/A	Gutter Ponding?	N/A	N/A	Gutter Slope (%)	N/A
N/A	Gutter Lip Ht (in)	N/A	N/A	Gutter X Slope (%)	N/A
N/A	Painted X Walk1?	Yes	N/A	Painted X Walk2?	N/A
	X Walk 1 Direction	To N		X Walk 2 Direction	N/A
N/A	X Walk 1 Width (in)	106.0	N/A	X Walk 2 Width (in)	N/A
	X Walk 1 Slope (%)	3.9		X Walk 2 Slope (%)	N/A
	X Walk 1 X Slope (%)	1.8		X Walk 2 X Slope (%)	N/A
N/A	Ramp inside XWalk1?	Yes	N/A	Ramp inside XWalk2?	N/A

Road Slope (%)	N/A	N/A	Clear Space?	N/A
	Road X Slope (%)	N/A	N/A	Clear Space to XWalk (in)	N/A
N/A	Any Obstructions?	N/A	N/A	Storm Grate/Utility Hazard?	N/A
	Obstruction Type			Storm Grate/Utility Type	
		N/A			N/A
			Yes	Surface Condition? (G/P)	Good
			N/A	Curb Slope (%)	6.6

Possible Solutions:

Remove & Replace Entire Ramp.

PROW/ADA:

R304.5.3, R304.3.2

Total Cost: \$ 1600.00
