# Access Compliance Report

## Public Rights-of-Way

### (Curb Ramps)

| ADA ID: 7D11E2B313C5 | Ramp Type: Directional2 | Initial Pass/Fail: Fail | Overall Compliance: No |

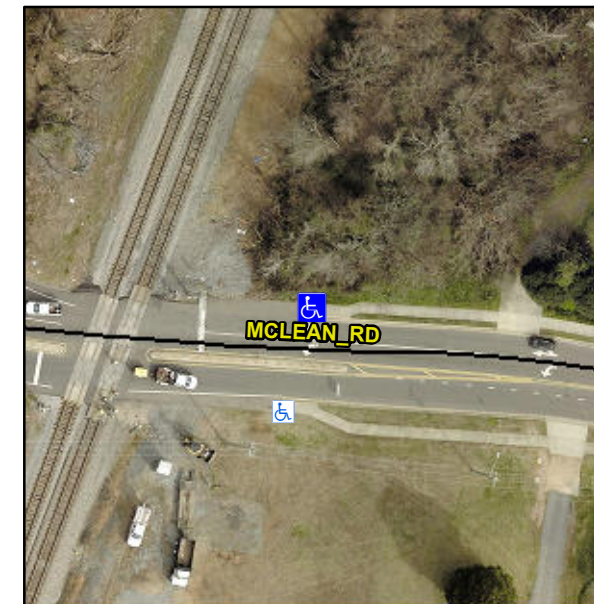
**R304.2.2**

| Compliance | Description | Data | Compliance | Description | Data |
|---|---|---|---|---|---|
| No | Ramp Slope (%) | 9.7 | N/A | Grade Break XSlope (%) | 0.0 |

**Remove & Replace Entire Ramp.**
