Access Compliance Report

Public Rights-of-Way

(Curb Ramps)

Intersection ID: 14749	Main Street: HOLLYFIELD_DR	Cross Street: KELSTON_PL	Location: NE
ADA ID: 7D13DBDE9577	Ramp Type: PerpDiag	Initial Pass/Fail: Fail	Overall Compliance: No
Severity Score: 46.25			
Codes/Mitigation Info/Possible Solution		Field Measurements/Component Compliance

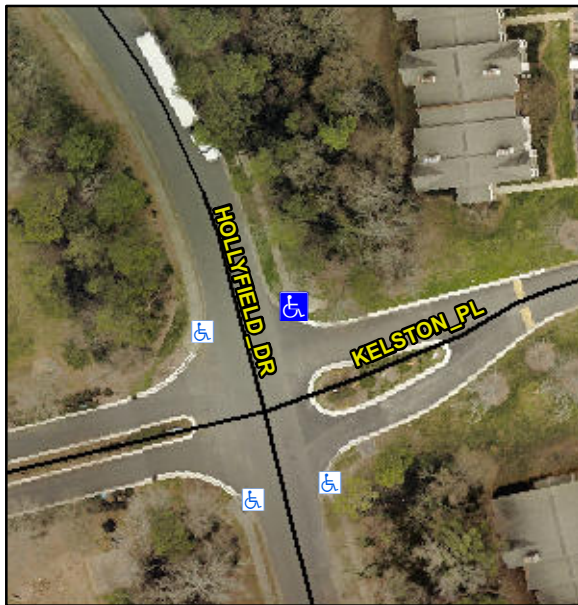
Not Found, R304.5.1, R304.2.2, R304.5.3

Compliance	Description	Data	Compliance	Description	Data
N/A	Ramp Length (in)	72.0	No	Ramp Slope (%)	9.1
No	Ramp Width (in)	44.0	No	Ramp XSlope (%)	7.2
N/A	Flare Type LT	N/A	N/A	Flare Type RT	N/A
N/A	Flare Slope LT (%)	N/A	N/A	Flare Slope RT (%)	N/A
N/A	Flare Traversable LT?	N/A	N/A	Flare Traversable RT?	N/A
N/A	Landing Length (in)	N/A	N/A	DWS Provided?	N/A
N/A	Landing Width (in)	N/A	N/A	DWS Contrast?	N/A
N/A	Landing Slope (%)	N/A	N/A	DWS Length (in)	N/A
N/A	Landing X Slope (%)	N/A	N/A	DWS Full Width?	N/A
N/A	Landing Curb? (Y/N)	N/A	N/A	DWS Offset (in)	N/A
N/A	Shared Landing?	N/A			
N/A	Gutter Ponding?	N/A	N/A	Gutter Slope (%)	N/A
N/A	Gutter Lip Ht (in)	0.5	N/A	Gutter X Slope (%)	N/A
N/A	Painted X Walk1?	No	N/A	Painted X Walk2?	No
	X Walk 1 Direction	To W		X Walk 2 Direction	To S
N/A	X Walk 1 Width (in)	N/A	N/A	X Walk 2 Width (in)	N/A
	X Walk 1 Slope (%)	4.7		X Walk 2 Slope (%)	2.6
	X Walk 1 X Slope (%)	3.5		X Walk 2 X Slope (%)	7.1

N/A	Ramp inside XWalk1?	N/A	N/A	Ramp inside XWalk2?	N/A
	Road Slope (%)	3.5	N/A	Clear Space?	N/A
	Road X Slope (%)	4.7	N/A	Clear Space to XWalk (in)	N/A
N/A	Any Obstructions?	N/A	N/A	Storm Grate/Utility Hazard?	N/A
	Obstruction Type			Storm Grate/Utility Type	
		N/A			N/A
		Yes		Surface Condition? (G/P)	Good

Remove & Replace Curb Ramp With Two New Directional Ramps or Equivalent.
