# Access Compliance Report

## Public Rights-of-Way

### (Curb Ramps)

Intersection ID: 32023	Main Street: CORNWALLIS_CAMP_DR	Cross Street: WESSYNTON_DR	Location: NE
ADA ID: 7D18446C0100	Ramp Type: PerpDiag	Initial Pass/Fail: Fail	Overall Compliance: No
Codes/Mitigation Info/Possible Solution		Field Measurements/Component Compliance

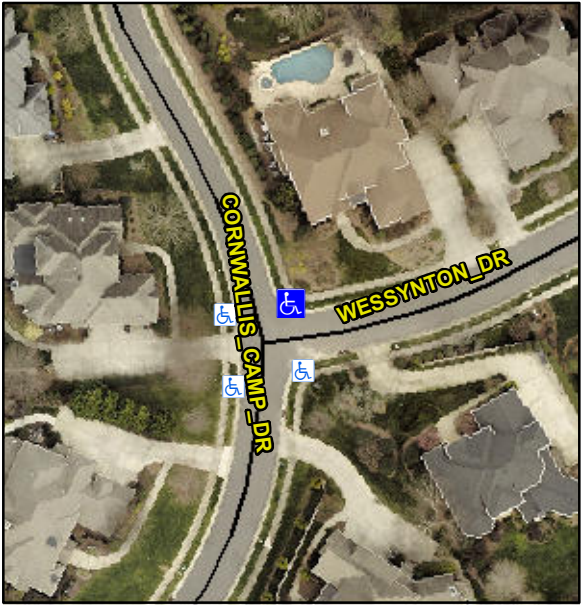
Possible Solutions:	Compliance	Description	Data	Compliance	Description	Data
	Remove & Replace Curb Ramp With Two New Directional Ramps or Equivalent.	N/A	Ramp Length (in)	48.0	No	Ramp Slope (%)	8.5
<p>Surveyor Notes:</p> <p>N/A</p> <p>PROW/ADA:</p> <p>Not Found, R304.5.1, R304.2.2, R304.5.3</p>		No	Ramp Width (in)	35.0	No	Ramp XSlope (%)	2.5
		N/A	Flare Type LT	N/A	N/A	Flare Type RT	N/A
		N/A	Flare Slope LT (%)	N/A	N/A	Flare Slope RT (%)	N/A
		N/A	Flare Traversable LT?	N/A	N/A	Flare Traversable RT?	N/A
		N/A	Landing Length (in)	N/A	N/A	DWS Provided?	N/A
		N/A	Landing Width (in)	N/A	N/A	DWS Contrast?	N/A
		N/A	Landing Slope (%)	N/A	N/A	DWS Length (in)	N/A
		N/A	Landing X Slope (%)	N/A	N/A	DWS Full Width?	N/A
		N/A	Landing Curb? (Y/N)	N/A	N/A	DWS Offset (in)	N/A
		N/A	Shared Landing?	N/A			
		N/A	Gutter Ponding?	N/A	N/A	Gutter Slope (%)	N/A
		N/A	Gutter Lip Ht (in)	N/A	N/A	Gutter X Slope (%)	N/A
		N/A	Painted X Walk1?	No	N/A	Painted X Walk2?	No

X Walk 1 Direction	To W		X Walk 2 Direction	To S
		N/A	X Walk 1 Width (in)	N/A	N/A	X Walk 2 Width (in)	N/A
			X Walk 1 Slope (%)	0.1		X Walk 2 Slope (%)	8.9
			X Walk 1 X Slope (%)	4.6		X Walk 2 X Slope (%)	0.8
		N/A	Ramp inside XWalk1?	N/A	N/A	Ramp inside XWalk2?	N/A
			Road Slope (%)	2.4	N/A	Clear Space?	N/A
			Road X Slope (%)	4.6	N/A	Clear Space to XWalk (in)	N/A
		N/A	Any Obstructions?	N/A	N/A	Storm Grate/Utility Hazard?	N/A
			Obstruction Type			Storm Grate/Utility Type	
				N/A			N/A
					Yes	Surface Condition? (G/P)	Good
Total Cost:		\$	3200.00
