Access Compliance Report

Public Rights-of-Way

(Curb Ramps)

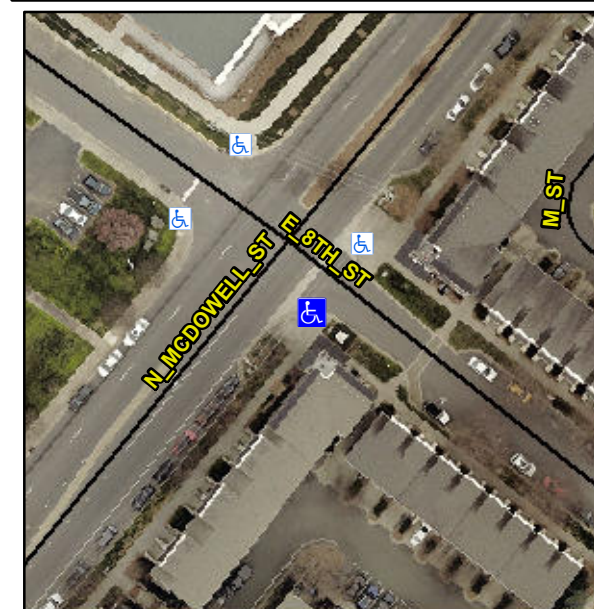
Intersection ID: 12739	Main Street: N_MCDOWELL_ST	Cross Street: E_8TH_ST	Location: S
ADA ID: 7D186A7650F7	Ramp Type: PerpDiag	Initial Pass/Fail: Pass	Overall Compliance: No
Severity Score: 0.25			
Codes/Mitigation Info/Possible Solution		Field Measurements/Component Compliance

Compliance	Description	Data	Compliance	Description	Data
N/A	Ramp Length (in)	74.0	Yes	Ramp Slope (%)	8.0
Yes	Ramp Width (in)	48.0	No	Ramp XSlope (%)	3.5
N/A	Flare Type LT	Sloped	N/A	Flare Type RT	N/A
N/A	Flare Slope LT (%)	9.4	Yes	Flare Slope RT (%)	9.0
N/A	Flare Traversable LT?	No	N/A	Flare Traversable RT?	Yes
Yes	Landing Length (in)	60.0	Yes	DWS Provided?	Yes
Yes	Landing Width (in)	60.0	Yes	DWS Contrast?	Yes
Yes	Landing Slope (%)	1.0	Yes	DWS Length (in)	24.0
Yes	Landing X Slope (%)	0.7	Yes	DWS Full Width?	Yes
N/A	Landing Curb? (Y/N)	No	Yes	DWS Offset (in)	2.0
N/A	Shared Landing?	No			
Yes	Gutter Ponding?	No	Yes	Gutter Slope (%)	1.5
Yes	Gutter Lip Ht (in)	0.0	Yes	Gutter X Slope (%)	1.6
N/A	Painted X Walk1?	No	N/A	Painted X Walk2?	No
	X Walk 1 Direction	To NE		X Walk 2 Direction	To NW
N/A	X Walk 1 Width (in)	N/A	N/A	X Walk 2 Width (in)	N/A
	X Walk 1 Slope (%)	0.9		X Walk 2 Slope (%)	0.4
	X Walk 1 X Slope (%)	0.3		X Walk 2 X Slope (%)	1.5

N/A	Ramp inside XWalk1?	N/A	N/A	Ramp inside XWalk2?	N/A
	Road Slope (%)	0.4	N/A	Clear Space?	Yes
	Road X Slope (%)	1.4	N/A	Clear Space to XWalk (in)	N/A
Yes	Any Obstructions?	No	Yes	Storm Grate/Utility Hazard?	No
	Obstruction Type			Storm Grate/Utility Type	
		N/A			N/A
			Yes	Surface Condition? (G/P)	Good

Possible Solutions:

Remove & Replace Curb Ramp With Two New Directional Ramps or Equivalent.

R304.5.3
