Access Compliance Report

Public Rights-of-Way

(Curb Ramps)

Intersection ID: 27847	Main Street: PARADISE RIDGE RD	Cross Street: NORTH COMMUNITY HOUSE RD	Location: NW
ADA ID: 7D1EEBC43514	Ramp Type: Perp	Initial Pass/Fail: Fail	Overall Compliance: No
Severity Score: 13.75			
Codes/Mitigation Info/Possible Solution		Field Measurements/Component Compliance

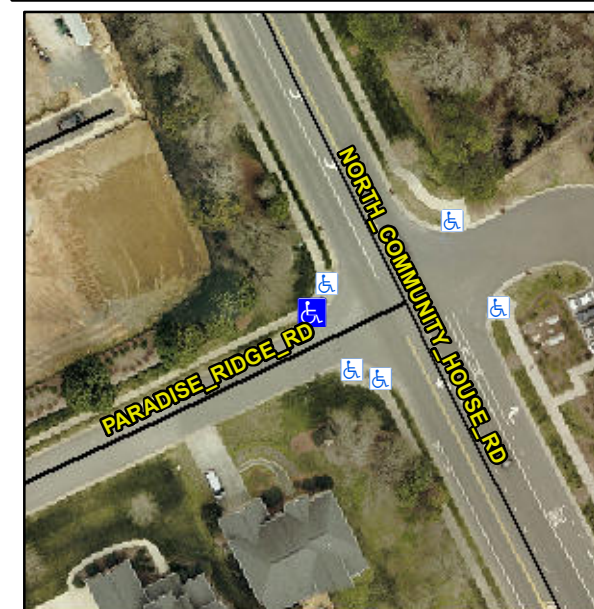
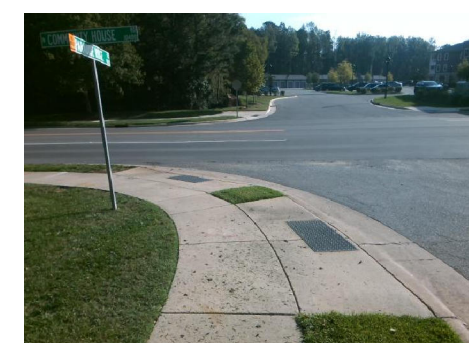
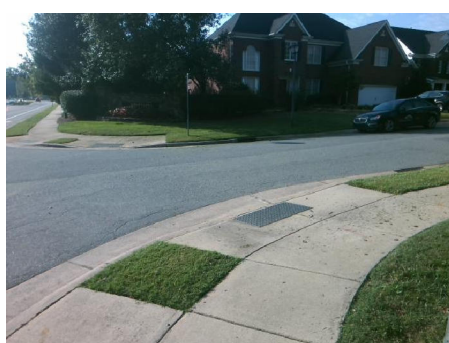
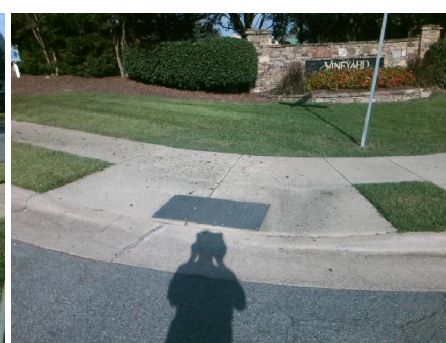
Compliance	Description	Data	Compliance	Description	Data
N/A	Ramp Length (in)	92.0	No	Ramp Slope (%)	8.8
Yes	Ramp Width (in)	48.0	No	Ramp XSlope (%)	4.6
N/A	Flare Type LT	N/A	N/A	Flare Type RT	N/A
N/A	Flare Slope LT (%)	N/A	N/A	Flare Slope RT (%)	N/A
N/A	Flare Traversable LT?	N/A	N/A	Flare Traversable RT?	N/A
N/A	Landing Length (in)	N/A	N/A	DWS Provided?	N/A
N/A	Landing Width (in)	N/A	N/A	DWS Contrast?	N/A
N/A	Landing Slope (%)	N/A	N/A	DWS Length (in)	N/A
N/A	Landing X Slope (%)	N/A	N/A	DWS Full Width?	N/A
N/A	Landing Curb? (Y/N)	N/A	N/A	DWS Offset (in)	N/A
N/A	Shared Landing?	N/A			
N/A	Gutter Ponding?	N/A	N/A	Gutter Slope (%)	N/A
N/A	Gutter Lip Ht (in)	N/A	N/A	Gutter X Slope (%)	N/A
N/A	Painted X Walk1?	No	N/A	Painted X Walk2?	N/A
	X Walk 1 Direction	To SE		X Walk 2 Direction	N/A
N/A	X Walk 1 Width (in)	N/A	N/A	X Walk 2 Width (in)	N/A
	X Walk 1 Slope (%)	0.5		X Walk 2 Slope (%)	N/A
	X Walk 1 X Slope (%)	3.6		X Walk 2 X Slope (%)	N/A

N/A	Ramp inside XWalk1?	N/A	N/A	Ramp inside XWalk2?	N/A
	Road Slope (%)	N/A	N/A	Clear Space?	N/A
	Road X Slope (%)	N/A	N/A	Clear Space to XWalk (in)	N/A
N/A	Any Obstructions?	N/A	N/A	Storm Grate/Utility Hazard?	N/A
	Obstruction Type			Storm Grate/Utility Type	
		N/A			N/A
			Yes	Surface Condition? (G/P)	Good

Remove & Replace Entire Ramp.

R304.2.2, R304.5.3
