# Access Compliance Report

## Public Rights-of-Way

### (Curb Ramps)

| Intersection ID: 7978 | Main Street: PAWTUCKETT_RD | Cross Street: SULLINS_RD | Location: NE |

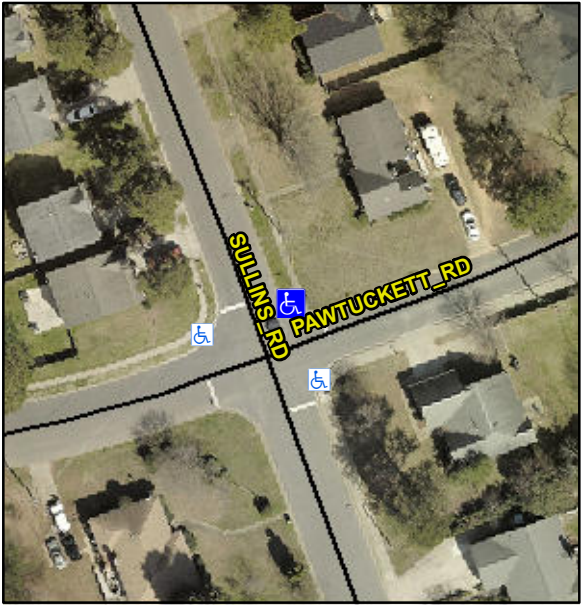
| ADA ID: 7D24594CCE3A | Ramp Type: PerpDiag | Initial Pass/Fail: Fail | Overall Compliance: No |

| Codes/Mitigation Info/Possible Solution | | | Field Measurements/Component Compliance | | |
|---|---|---|---|---|---|
| | <b>Remove &amp; Replace Curb Ramp With Two New Directional Ramps or Equivalent.</b> | | <b>No</b> | Ramp Length (in) | <b>83.5</b> |
| | | | <b>No</b> | Ramp Width (in) | <b>47.5</b> |
| <p>Surveyor Notes:</p> <p><b>N/A</b></p> <p>PROW/ADA:</p> <p><b>Not Found, R304.5.1, R304.2.2, R304.5.3</b></p> | | | <b>N/A</b> | Flare Type RT | <b>N/A</b> |
| | | | <b>N/A</b> | Gutter Lip Ht (in) | <b>1.0</b> |

| Codes/Mitigation Info/Possible Solution | | | Field Measurements/Component Compliance | | |
|---|---|---|---|---|---|
| Total Cost: | | <b>\$ 3200.00</b> | <b>N/A</b> | Storm Grate/Utility Hazard? | <b>N/A</b> |
