Access Compliance Report

Public Rights-of-Way

(Curb Ramps)

Intersection ID: 17665	Main Street: MENDENHALL_CT	Cross Street: TANGLE_DR	Location:	E
ADA ID: 7D2C79EB3D08	Ramp Type: BlendTrans1	Initial Pass/Fail: Fail	Overall Compliance: No	Severity Score: 1.25

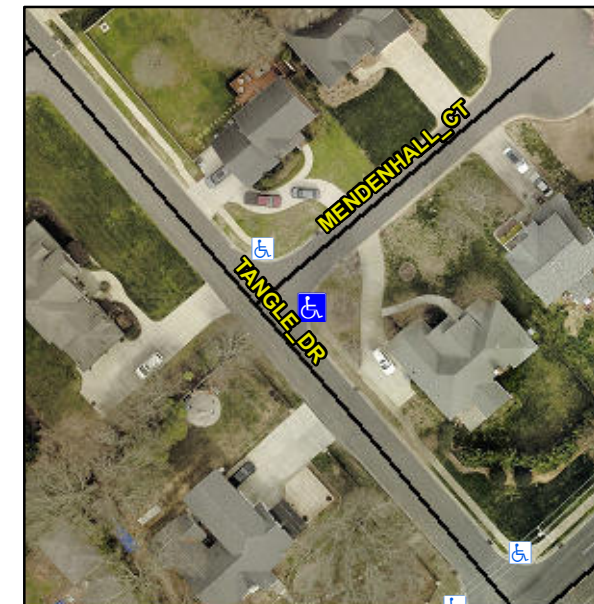
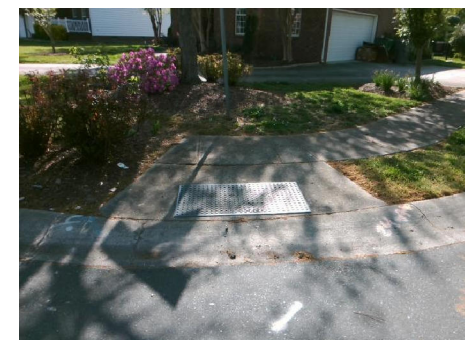
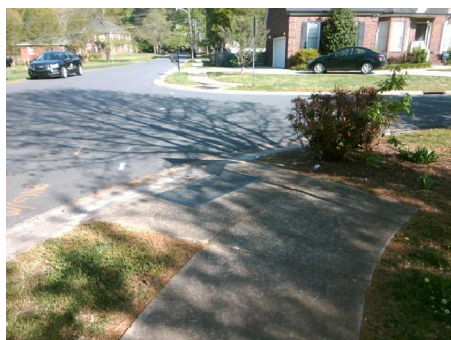
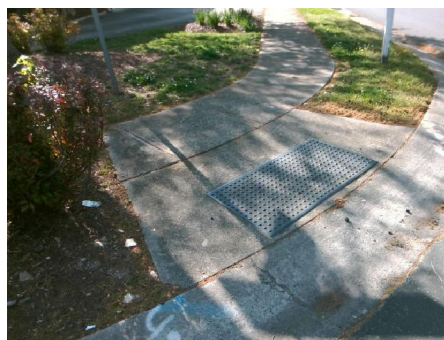
Not Found, R304.5.3

Compliance	Description	Data	Compliance	Description	Data
N/A	Ramp Length (in)	48.0	Yes	BlendTrans Slope (%)	4.0
Yes	Ramp Width (in)	48.0	No	BlendTrans XSlope (%)	3.3
N/A	Flare Type LT	N/A	N/A	Flare Type RT	N/A
N/A	Flare Slope LT (%)	N/A	N/A	Flare Slope RT (%)	N/A
N/A	Flare Traversable LT?	N/A	N/A	Flare Traversable RT?	N/A
N/A	Landing Length (in)	N/A	N/A	DWS Provided?	N/A
N/A	Landing Width (in)	N/A	N/A	DWS Contrast?	N/A
N/A	Landing Slope (%)	N/A	N/A	DWS Length (in)	N/A
N/A	Landing X Slope (%)	N/A	N/A	DWS Full Width?	N/A
N/A	Landing Curb? (Y/N)	N/A	N/A	DWS Offset (in)	N/A
N/A	Shared Landing?	N/A			
N/A	Gutter Ponding?	N/A	N/A	Gutter Slope (%)	N/A
N/A	Gutter Lip Ht (in)	N/A	N/A	Gutter X Slope (%)	N/A
N/A	Painted X Walk1?	No	N/A	Painted X Walk2?	N/A
	X Walk 1 Direction	To NW		X Walk 2 Direction	N/A
	X Walk 1 Width (in)	N/A		X Walk 2 Width (in)	N/A
	X Walk 1 Slope (%)	1.9		X Walk 2 Slope (%)	N/A
	X Walk 1 X Slope (%)	2.0		X Walk 2 X Slope (%)	N/A

N/A	Ramp inside XWalk1?	N/A	N/A	Ramp inside XWalk2?	N/A
	Road Slope (%)	2.0		Clear Space?	N/A
	Road X Slope (%)	1.9	N/A	Clear Space to XWalk (in)	N/A
N/A	Any Obstructions?	N/A	N/A	Storm Grate/Utility Hazard?	N/A
	Obstruction Type			Storm Grate/Utility Type	
		N/A			N/A
			Yes	Surface Condition? (G/P)	Good
			No	Curb Slope (%)	8.8

Remove & Replace Curb Ramp With Two New Directional Ramps or Equivalent.
