Access Compliance Report

Public Rights-of-Way

(Curb Ramps)

Intersection ID: 11551	Main Street: E_16TH_ST	Cross Street: N_CALDWELL_ST	Location: S
ADA ID: 7D353FA24065	Ramp Type: PerpDiag	Initial Pass/Fail: Fail	Overall Compliance: No
Severity Score: 12.5			
Codes/Mitigation Info/Possible Solution		Field Measurements/Component Compliance

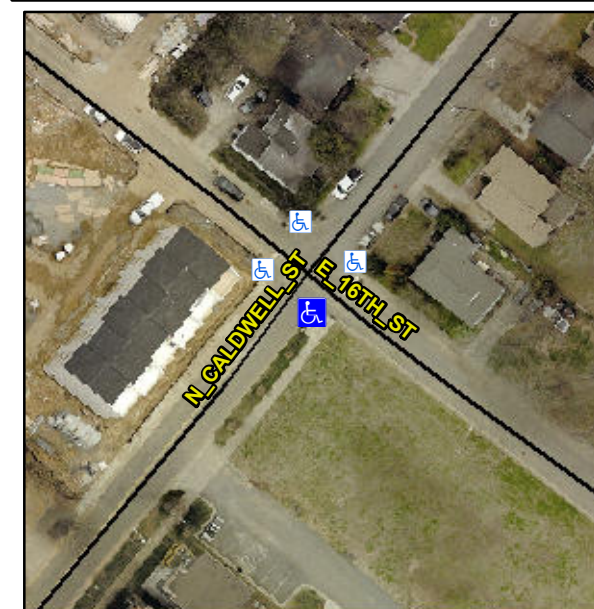
PROW/ADA:

Not Found, R304.2.2

Compliance	Description	Data	Compliance	Description	Data
N/A	Ramp Length (in)	63.0	No	Ramp Slope (%)	8.8
Yes	Ramp Width (in)	48.0	Yes	Ramp XSlope (%)	0.2
N/A	Flare Type LT	N/A	N/A	Flare Type RT	N/A
N/A	Flare Slope LT (%)	N/A	N/A	Flare Slope RT (%)	N/A
N/A	Flare Traversable LT?	N/A	N/A	Flare Traversable RT?	N/A
N/A	Landing Length (in)	N/A	N/A	DWS Provided?	N/A
N/A	Landing Width (in)	N/A	N/A	DWS Contrast?	N/A
N/A	Landing Slope (%)	N/A	N/A	DWS Length (in)	N/A
N/A	Landing X Slope (%)	N/A	N/A	DWS Full Width?	N/A
N/A	Landing Curb? (Y/N)	N/A	N/A	DWS Offset (in)	N/A
N/A	Shared Landing?	N/A			
N/A	Gutter Ponding?	N/A	N/A	Gutter Slope (%)	N/A
N/A	Gutter Lip Ht (in)	N/A	N/A	Gutter X Slope (%)	N/A
N/A	Painted X Walk1?	No	N/A	Painted X Walk2?	No
	X Walk 1 Direction	To NE		X Walk 2 Direction	To NW
N/A	X Walk 1 Width (in)	N/A	N/A	X Walk 2 Width (in)	N/A
	X Walk 1 Slope (%)	9.6		X Walk 2 Slope (%)	4.1
	X Walk 1 X Slope (%)	3.4		X Walk 2 X Slope (%)	2.6

N/A	Ramp inside XWalk1?	N/A	N/A	Ramp inside XWalk2?	N/A
	Road Slope (%)	0.6	N/A	Clear Space?	N/A
	Road X Slope (%)	7.0	N/A	Clear Space to XWalk (in)	N/A
N/A	Any Obstructions?	N/A	N/A	Storm Grate/Utility Hazard?	N/A
	Obstruction Type			Storm Grate/Utility Type	
		N/A			N/A
		Yes		Surface Condition? (G/P)	Good

Possible Solutions:

Remove & Replace Curb Ramp With Two New Directional Ramps or Equivalent.
