# Access Compliance Report

## Public Rights-of-Way

### (Curb Ramps)

Intersection ID: 13749	Main Street: BARRINGER_DR	Cross Street: REMOUNT_RD	Location: NE
ADA ID: 7D354BFFCA6B	Ramp Type: Perp	Initial Pass/Fail: Fail	Overall Compliance: No
Severity Score: 8.75			
Codes/Mitigation Info/Possible Solution		Field Measurements/Component Compliance

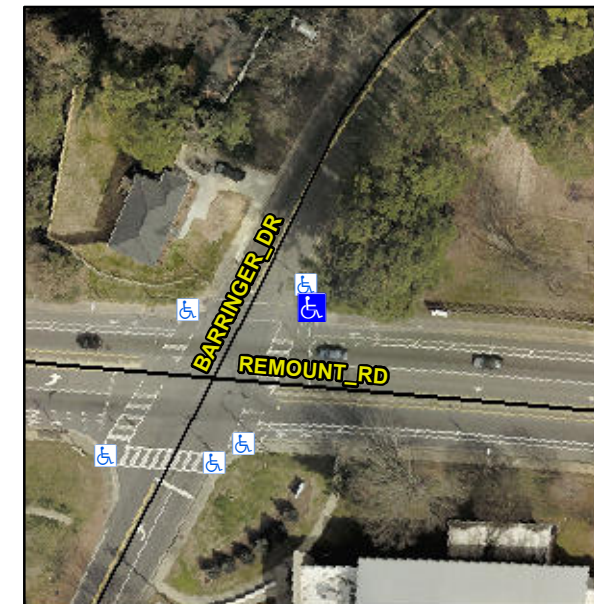
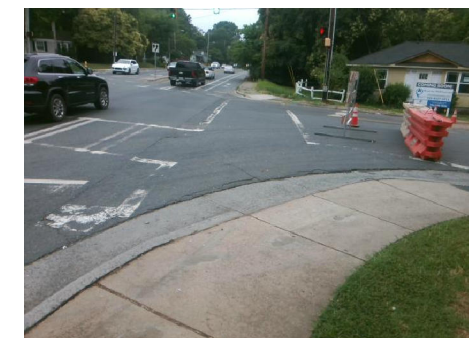
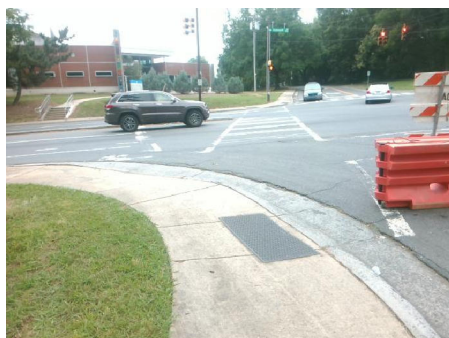
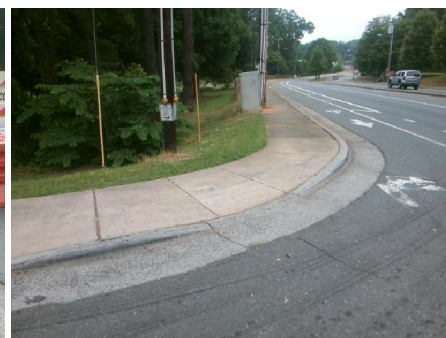
Compliance	Description	Data	Compliance	Description	Data
N/A	Ramp Length (in)	60.0	Yes	Ramp Slope (%)	5.4
No	Ramp Width (in)	38.0	Yes	Ramp XSlope (%)	1.8
N/A	Flare Type LT	N/A	N/A	Flare Type RT	N/A
N/A	Flare Slope LT (%)	N/A	N/A	Flare Slope RT (%)	N/A
N/A	Flare Traversable LT?	N/A	N/A	Flare Traversable RT?	N/A
N/A	Landing Length (in)	N/A	N/A	DWS Provided?	N/A
N/A	Landing Width (in)	N/A	N/A	DWS Contrast?	N/A
N/A	Landing Slope (%)	N/A	N/A	DWS Length (in)	N/A
N/A	Landing X Slope (%)	N/A	N/A	DWS Full Width?	N/A
N/A	Landing Curb? (Y/N)	N/A	N/A	DWS Offset (in)	N/A
N/A	Shared Landing?	N/A			
N/A	Gutter Ponding?	N/A	N/A	Gutter Slope (%)	N/A
N/A	Gutter Lip Ht (in)	N/A	N/A	Gutter X Slope (%)	N/A
N/A	Painted X Walk1?	Yes	N/A	Painted X Walk2?	N/A
	X Walk 1 Direction	To SW		X Walk 2 Direction	N/A
N/A	X Walk 1 Width (in)	116.0	N/A	X Walk 2 Width (in)	N/A
	X Walk 1 Slope (%)	0.8		X Walk 2 Slope (%)	N/A
	X Walk 1 X Slope (%)	3.5		X Walk 2 X Slope (%)	N/A

N/A	Ramp inside XWalk1?	Yes	N/A	Ramp inside XWalk2?	N/A
	Road Slope (%)	N/A	N/A	Clear Space?	N/A
	Road X Slope (%)	N/A	N/A	Clear Space to XWalk (in)	N/A
N/A	Any Obstructions?	N/A	N/A	Storm Grate/Utility Hazard?	N/A
	Obstruction Type			Storm Grate/Utility Type	
		N/A			N/A
		Yes		Surface Condition? (G/P)	Good

**Remove & Replace Entire Ramp.**

**R304.5.1**
