Access Compliance Report

Public Rights-of-Way

(Curb Ramps)

Intersection ID: 49384	Main Street: SOUTH_DEVON_ST	Cross Street: SHORTHORN_ST	Location: W
ADA ID: 7D37BAFACC61	Ramp Type: Perp	Initial Pass/Fail: Fail	Overall Compliance: No
		Severity Score: 22.5	
Codes/Mitigation Info/Possible Solution		Field Measurements/Component Compliance

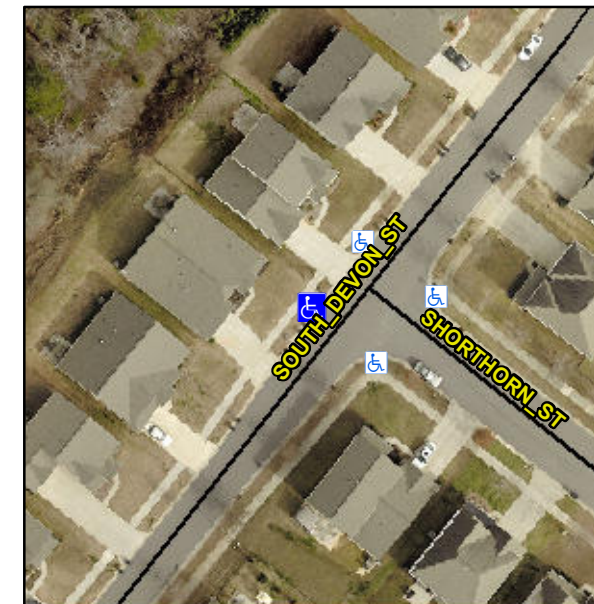
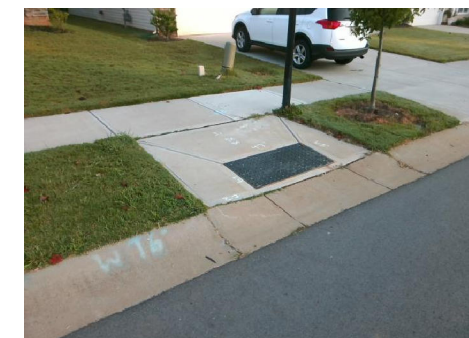
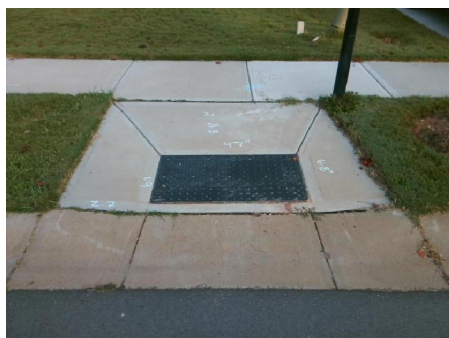
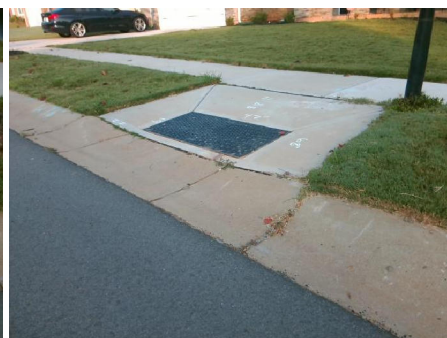
Not Found, R304.5.1, R304.2.2, R304.5.3

Compliance	Description	Data	Compliance	Description	Data
N/A	Ramp Length (in)	68.0	No	Ramp Slope (%)	8.8
No	Ramp Width (in)	47.0	No	Ramp XSlope (%)	3.1
N/A	Flare Type LT	N/A	N/A	Flare Type RT	N/A
N/A	Flare Slope LT (%)	N/A	N/A	Flare Slope RT (%)	N/A
N/A	Flare Traversable LT?	N/A	N/A	Flare Traversable RT?	N/A
N/A	Landing Length (in)	N/A	N/A	DWS Provided?	N/A
N/A	Landing Width (in)	N/A	N/A	DWS Contrast?	N/A
N/A	Landing Slope (%)	N/A	N/A	DWS Length (in)	N/A
N/A	Landing X Slope (%)	N/A	N/A	DWS Full Width?	N/A
N/A	Landing Curb? (Y/N)	N/A	N/A	DWS Offset (in)	N/A
N/A	Shared Landing?	N/A			
N/A	Gutter Ponding?	N/A	N/A	Gutter Slope (%)	N/A
N/A	Gutter Lip Ht (in)	N/A	N/A	Gutter X Slope (%)	N/A
N/A	Painted X Walk1?	No	N/A	Painted X Walk2?	N/A
	X Walk 1 Direction	To SE		X Walk 2 Direction	N/A
N/A	X Walk 1 Width (in)	N/A	N/A	X Walk 2 Width (in)	N/A
	X Walk 1 Slope (%)	1.9		X Walk 2 Slope (%)	N/A
	X Walk 1 X Slope (%)	2.7		X Walk 2 X Slope (%)	N/A

N/A	Ramp inside XWalk1?	N/A	N/A	Ramp inside XWalk2?	N/A
	Road Slope (%)	N/A	N/A	Clear Space?	N/A
	Road X Slope (%)	N/A	N/A	Clear Space to XWalk (in)	N/A
N/A	Any Obstructions?	N/A	N/A	Storm Grate/Utility Hazard?	N/A
	Obstruction Type			Storm Grate/Utility Type	
		N/A			N/A
			Yes	Surface Condition? (G/P)	Good

Remove & Replace Entire Ramp.
