Access Compliance Report

Public Rights-of-Way

(Curb Ramps)

Intersection ID: 3731	Main Street: HARRIS_CORNERS_PY	Cross Street: HARRIS_OAKS_BV	Location: NE
ADA ID: 7D393F721364	Ramp Type: Perp	Initial Pass/Fail: Fail	Overall Compliance: No
Severity Score: 8.75			
Codes/Mitigation Info/Possible Solution		Field Measurements/Component Compliance

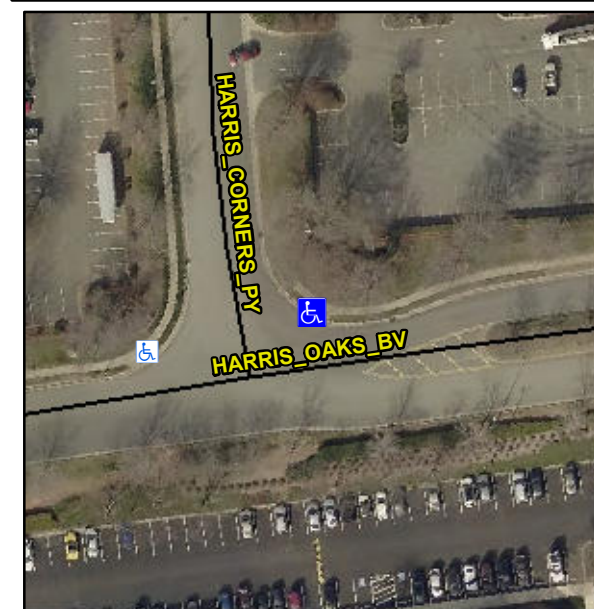
Not Found, R304.5.1

Compliance	Description	Data	Compliance	Description	Data
N/A	Ramp Length (in)	48.0	Yes	Ramp Slope (%)	8.1
No	Ramp Width (in)	47.0	Yes	Ramp XSlope (%)	0.4
N/A	Flare Type LT	N/A	N/A	Flare Type RT	N/A
N/A	Flare Slope LT (%)	N/A	N/A	Flare Slope RT (%)	N/A
N/A	Flare Traversable LT?	N/A	N/A	Flare Traversable RT?	N/A
N/A	Landing Length (in)	N/A	N/A	DWS Provided?	N/A
N/A	Landing Width (in)	N/A	N/A	DWS Contrast?	N/A
N/A	Landing Slope (%)	N/A	N/A	DWS Length (in)	N/A
N/A	Landing X Slope (%)	N/A	N/A	DWS Full Width?	N/A
N/A	Landing Curb? (Y/N)	N/A	N/A	DWS Offset (in)	N/A
N/A	Shared Landing?	N/A			
N/A	Gutter Ponding?	N/A	N/A	Gutter Slope (%)	N/A
N/A	Gutter Lip Ht (in)	N/A	N/A	Gutter X Slope (%)	N/A
N/A	Painted X Walk1?	No	N/A	Painted X Walk2?	N/A
	X Walk 1 Direction	To W		X Walk 2 Direction	N/A
N/A	X Walk 1 Width (in)	N/A	N/A	X Walk 2 Width (in)	N/A
	X Walk 1 Slope (%)	0.7		X Walk 2 Slope (%)	N/A
	X Walk 1 X Slope (%)	1.0		X Walk 2 X Slope (%)	N/A

Possible Solutions:

Remove & Replace Entire Ramp.

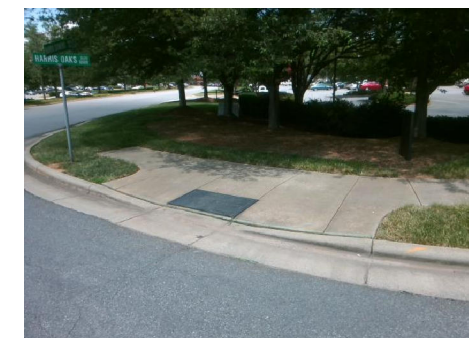
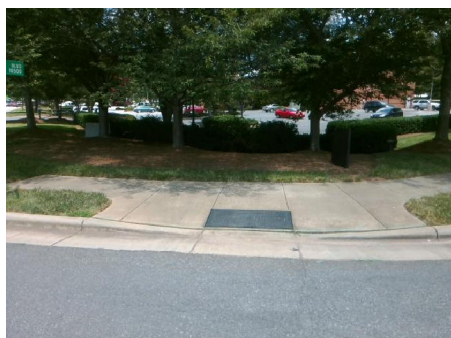
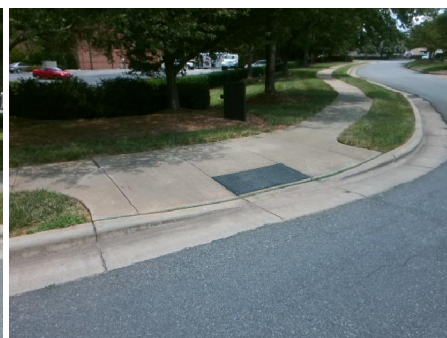
N/A	Ramp inside XWalk1?	N/A	N/A	Ramp inside XWalk2?	N/A
	Road Slope (%)	N/A	N/A	Clear Space?	N/A
	Road X Slope (%)	N/A	N/A	Clear Space to XWalk (in)	N/A
N/A	Any Obstructions?	N/A	N/A	Storm Grate/Utility Hazard?	N/A
	Obstruction Type			Storm Grate/Utility Type	
		N/A			N/A
			Yes	Surface Condition? (G/P)	Good
