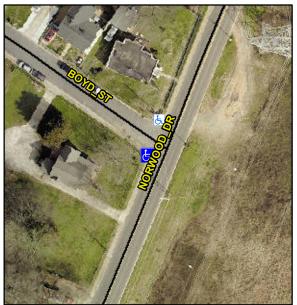
Intersection ID: 9100Main Street:BOYD\_STCross Street:NORWOOD\_DRLocation:SADA ID: 7D3EF81AB125Ramp Type:PerpInitial Pass/Fail:FailOverall Compliance:NoSeverity Score:12.5

Field Measurements/Component Compliance							
Comp	liance Description	Data	Comp	liance	Description	Data	
N/A	Ramp Length (in)	47.0	No	Ramp	Slope (%)	11.3	
Yes	Ramp Width (in)	48.0	Yes	Ramp	XSlope (%)	0.1	
N/A	Flare Type LT	N/A	N/A	Flare	Type RT	N/A	
N/A	Flare Slope LT (%)	N/A	N/A	Flare	Slope RT (%)	N/A	
N/A	Flare Traversable LT?	N/A	N/A	Flare	Traversable RT?	N/A	
N/A	Landing Length (in)	N/A	N/A	DWS	Provided?	N/A	
N/A	Landing Width (in)	N/A	N/A	DWS	Contrast?	N/A	
N/A	Landing Slope (%)	N/A	N/A	DWS	Length (in)	N/A	
N/A	Landing X Slope (%)	N/A	N/A	DWS	Full Width?	N/A	
N/A	Landing Curb? (Y/N)	N/A	N/A	DWS	Offset (in)	N/A	
N/A	Shared Landing?	N/A					
N/A	Gutter Ponding?	N/A	N/A	Gutte	r Slope (%)	N/A	
N/A	Gutter Lip Ht (in)	N/A	N/A	Gutte	r X Slope (%)	N/A	
N/A	Painted X Walk1?	No	N/A	Paint	ed X Walk2?	N/A	
	X Walk 1 Direction	To NE		X Wa	lk 2 Direction	N/A	
N/A	X Walk 1 Width (in)	N/A	N/A	X Wa	lk 2 Width (in)	N/A

Possible Solutions:	Co		
Remove & Replace Entire Ramp.			
·	Ye		
	N/A		
Surveyor Notes:	N/A		
N/A	N/A		
	N/A		
	N/A		
	N/A		
PROW/ADA:	N/A		
Not Found, R304.2.2	N/A		
	N/		
	N/A		
	N/A
