Access Compliance Report

Public Rights-of-Way

(Curb Ramps)

Intersection ID: 5062	Main Street: CLIFFVALE_CT	Cross Street: HEDGECREST_PL	Location: SE
ADA ID: 7D41ADD45B63	Ramp Type: Directional1	Initial Pass/Fail: Fail	Overall Compliance: No
			Severity Score: 33.75

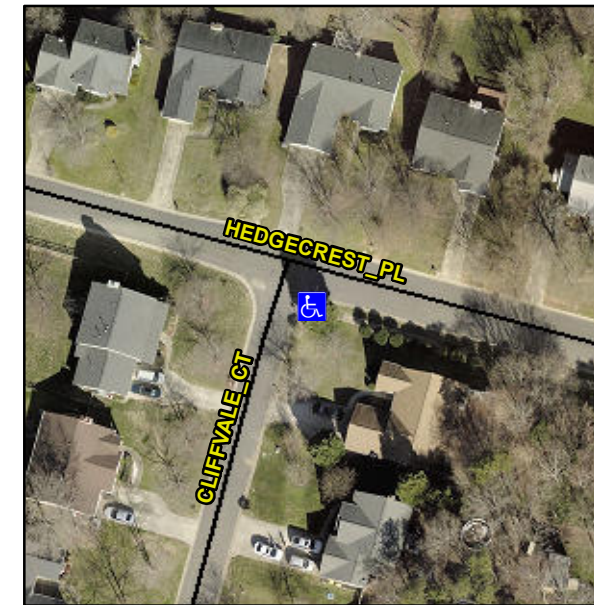
Compliance	Description	Data	Compliance	Description	Data
N/A	Ramp Length (in)	50.0	N/A	Grade Break?	N/A
No	Ramp Width (in)	43.0	N/A	Grade Break Slope (%)	0.0
No	Ramp Slope (%)	18.0	N/A	Grade Break XSlope (%)	0.0
Yes	Ramp XSlope (%)	1.8			
N/A	Flare Type LT	N/A	N/A	Flare Type RT	N/A
N/A	Flare Slope LT (%)	N/A	N/A	Flare Slope RT (%)	0.0
N/A	Flare Traversable LT?	N/A	N/A	Flare Traversable RT?	N/A
N/A	Landing Length (in)	0.0	N/A	DWS Provided?	N/A
N/A	Landing Width (in)	0.0	N/A	DWS Contrast?	N/A
N/A	Landing Slope (%)	0.0	N/A	DWS Length (in)	N/A
N/A	Landing X Slope (%)	0.0	N/A	DWS Full Width?	N/A
N/A	Landing Curb? (Y/N)	N/A	N/A	DWS Offset LT (in)	N/A
N/A	Shared Landing?	N/A	N/A	DWS Offset RT (in)	N/A
N/A	Gutter Ponding?	0.0	N/A	Gutter Slope (%)	N/A
N/A	Gutter Lip Ht (in)	0.0	N/A	Gutter X Slope (%)	N/A
N/A	Painted X Walk1?	No		Road Slope (%)	1.0
	X Walk 1 Direction	To W		Road X Slope (%)	1.0
	X Walk 1 Width (in)	N/A		Clear Space?	N/A

X Walk 1 Slope (%)	1.0	N/A	Clear Space to XWalk (in)	N/A
	X Walk 1 X Slope (%)	1.0	N/A	Storm Grate/Utility Hazard?	N/A
N/A	Ramp inside XWalk1?	N/A		Storm Grate/Utility Type	
N/A	Any Obstructions?	N/A			N/A
	Obstruction Type		Yes	Surface Condition? (G/P)	Good
			N/A	Curb Slope (%)	N/A

Possible Solutions:

Remove & Replace Entire Ramp.
