# Access Compliance Report

## Public Rights-of-Way

### (Curb Ramps)

Intersection ID: 11119	Main Street: WALNUT_AV	Cross Street: W_4TH_ST	Location:	S
ADA ID: 7D4EFF67F6ED	Ramp Type: Perp	Initial Pass/Fail: Fail	Overall Compliance: No	Severity Score: 10
Codes/Mitigation Info/Possible Solution		Field Measurements/Component Compliance

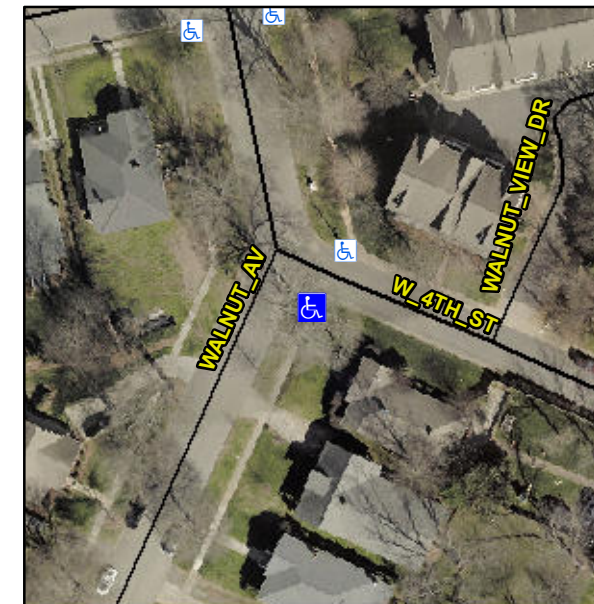
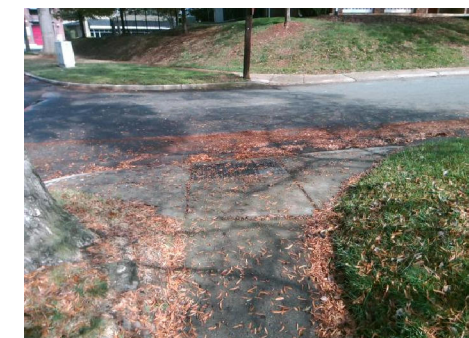
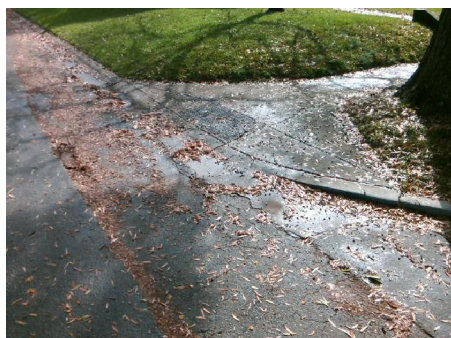
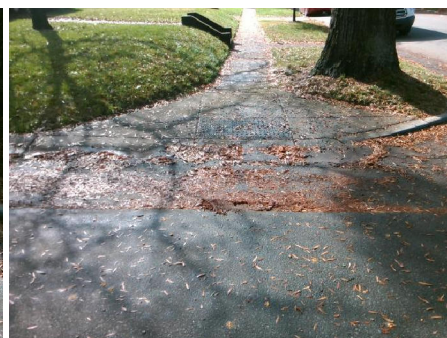
**Not Found, R304.5.1, R304.5.3**

Compliance	Description	Data	Compliance	Description	Data
N/A	Ramp Length (in)	70.0	Yes	Ramp Slope (%)	6.3
No	Ramp Width (in)	47.0	No	Ramp XSlope (%)	2.9
N/A	Flare Type LT	N/A	N/A	Flare Type RT	N/A
N/A	Flare Slope LT (%)	N/A	N/A	Flare Slope RT (%)	N/A
N/A	Flare Traversable LT?	N/A	N/A	Flare Traversable RT?	N/A
N/A	Landing Length (in)	N/A	N/A	DWS Provided?	N/A
N/A	Landing Width (in)	N/A	N/A	DWS Contrast?	N/A
N/A	Landing Slope (%)	N/A	N/A	DWS Length (in)	N/A
N/A	Landing X Slope (%)	N/A	N/A	DWS Full Width?	N/A
N/A	Landing Curb? (Y/N)	N/A	N/A	DWS Offset (in)	N/A
N/A	Shared Landing?	N/A			
N/A	Gutter Ponding?	N/A	N/A	Gutter Slope (%)	N/A
N/A	Gutter Lip Ht (in)	N/A	N/A	Gutter X Slope (%)	N/A
N/A	Painted X Walk1?	No	N/A	Painted X Walk2?	N/A
	X Walk 1 Direction	To NE		X Walk 2 Direction	N/A
N/A	X Walk 1 Width (in)	N/A	N/A	X Walk 2 Width (in)	N/A
	X Walk 1 Slope (%)	4.9		X Walk 2 Slope (%)	N/A
	X Walk 1 X Slope (%)	3.3		X Walk 2 X Slope (%)	N/A

N/A	Ramp inside XWalk1?	N/A	N/A	Ramp inside XWalk2?	N/A
	Road Slope (%)	N/A	N/A	Clear Space?	N/A
	Road X Slope (%)	N/A	N/A	Clear Space to XWalk (in)	N/A
N/A	Any Obstructions?	N/A	N/A	Storm Grate/Utility Hazard?	N/A
	Obstruction Type			Storm Grate/Utility Type	
		N/A			N/A
			Yes	Surface Condition? (G/P)	Good

**Remove & Replace Entire Ramp.**

Total Cost: \$ 1850.00
