Access Compliance Report

Public Rights-of-Way

(Curb Ramps)

Intersection ID: 7699	Main Street: MT_KISCO_DR	Cross Street: SQUIRREL_HILL_RD	Location: SE
ADA ID: 7D5468464FDE	Ramp Type: Perp	Initial Pass/Fail: Fail	Overall Compliance: No
Severity Score: 10			
Codes/Mitigation Info/Possible Solution		Field Measurements/Component Compliance

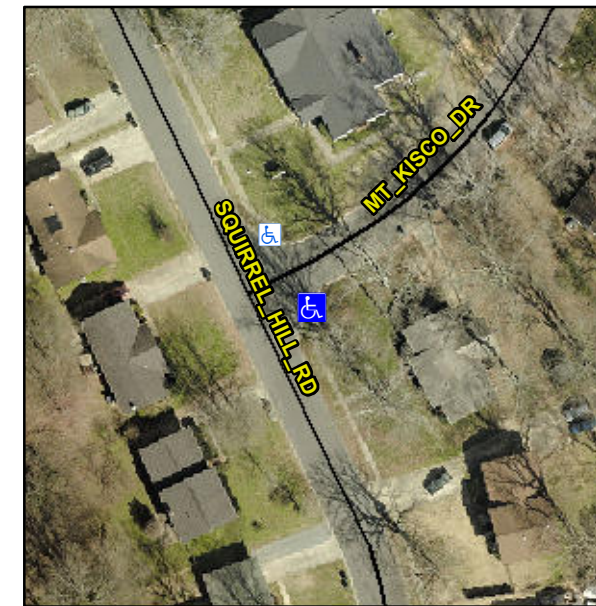
Not Found, R304.5.1, R304.5.3

Compliance	Description	Data	Compliance	Description	Data
N/A	Ramp Length (in)	47.0	Yes	Ramp Slope (%)	5.2
No	Ramp Width (in)	41.0	No	Ramp XSlope (%)	2.8
N/A	Flare Type LT	N/A	N/A	Flare Type RT	N/A
N/A	Flare Slope LT (%)	N/A	N/A	Flare Slope RT (%)	N/A
N/A	Flare Traversable LT?	N/A	N/A	Flare Traversable RT?	N/A
N/A	Landing Length (in)	N/A	N/A	DWS Provided?	N/A
N/A	Landing Width (in)	N/A	N/A	DWS Contrast?	N/A
N/A	Landing Slope (%)	N/A	N/A	DWS Length (in)	N/A
N/A	Landing X Slope (%)	N/A	N/A	DWS Full Width?	N/A
N/A	Landing Curb? (Y/N)	N/A	N/A	DWS Offset (in)	N/A
N/A	Shared Landing?	N/A			
N/A	Gutter Ponding?	N/A	N/A	Gutter Slope (%)	N/A
N/A	Gutter Lip Ht (in)	N/A	N/A	Gutter X Slope (%)	N/A
N/A	Painted X Walk1?	No	N/A	Painted X Walk2?	N/A
	X Walk 1 Direction	To N		X Walk 2 Direction	N/A
N/A	X Walk 1 Width (in)	N/A	N/A	X Walk 2 Width (in)	N/A
	X Walk 1 Slope (%)	2.5		X Walk 2 Slope (%)	N/A
	X Walk 1 X Slope (%)	1.8		X Walk 2 X Slope (%)	N/A

N/A	Ramp inside XWalk1?	N/A	N/A	Ramp inside XWalk2?	N/A
	Road Slope (%)	N/A	N/A	Clear Space?	N/A
	Road X Slope (%)	N/A	N/A	Clear Space to XWalk (in)	N/A
N/A	Any Obstructions?	N/A	N/A	Storm Grate/Utility Hazard?	N/A
	Obstruction Type			Storm Grate/Utility Type	
		N/A			N/A
			Yes	Surface Condition? (G/P)	Good

Possible Solutions:

Remove & Replace Entire Ramp.
