Access Compliance Report Public Rights-of-Way (Curb Ramps)

Intersection ID: 11911 Main Street: W_7TH_ST Cross Street: N_CHURCH_ST Location: N

ADA ID: 7D54ACD09A36 Ramp Type: PerpDiag Initial Pass/Fail: Fail Overall Compliance: No Severity Score: 13.75

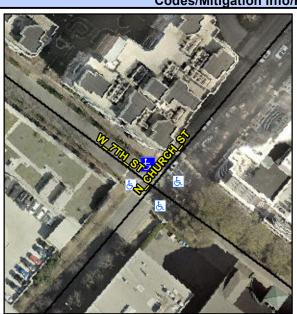
Not Found, R304.2.2, R304.5.3

Field Measurements/Component Compliance						
Compliance Description		Data	Comp	oliance Description	Data	
ı	N/A	Ramp Length (in)	56.0	No	Ramp Slope (%)	8.9
,	Yes	Ramp Width (in)	50.0	No	Ramp XSlope (%)	3.9
ı	N/A	Flare Type LT	N/A	N/A	Flare Type RT	N/A
ı	N/A	Flare Slope LT (%)	N/A	N/A	Flare Slope RT (%)	N/A
ı	N/A	Flare Traversable LT?	N/A	N/A	Flare Traversable RT?	N/A
ı	N/A	Landing Length (in)	N/A	N/A	DWS Provided?	N/A
ı	N/A	Landing Width (in)	N/A	N/A	DWS Contrast?	N/A
ı	N/A	Landing Slope (%)	N/A	N/A	DWS Length (in)	N/A
ı	N/A	Landing X Slope (%)	N/A	N/A	DWS Full Width?	N/A
ı	N/A	Landing Curb? (Y/N)	N/A	N/A	DWS Offset (in)	N/A
ı	N/A	Shared Landing?	N/A			
ı	N/A	Gutter Ponding?	N/A	N/A	Gutter Slope (%)	N/A
ı	N/A	Gutter Lip Ht (in)	N/A	N/A	Gutter X Slope (%)	N/A
ı	N/A	Painted X Walk1?	Yes	N/A	Painted X Walk2?	Yes
		X Walk 1 Direction	To SW		X Walk 2 Direction	To SE
ı	N/A	X Walk 1 Width (in)	101.0	N/A	X Walk 2 Width (in)	85.0

X Walk 1 Slope (%)	3.2		X Walk 2 Slope (%)	5.0
		X Walk 1 X Slope (%)	4.8		X Walk 2 X Slope (%)	4.0
ı	N/A	Ramp inside XWalk1?	Yes	N/A	Ramp inside XWalk2?	Yes
		Road Slope (%)	0.1	N/A	Clear Space?	N/A
		Road X Slope (%)	5.7	N/A	Clear Space to XWalk (in)	N/A
	N/A	Any Obstructions?	N/A	N/A	Storm Grate/Utility Hazard?	N/A
		Obstruction Type			Storm Grate/Utility Type	
			N/A			N/A
				Yes	Surface Condition? (G/P)	Good
112	1

Remove & Replace Curb Ramp With Two New Directional Ramps or Equivalent.

Total Cost: \$ 3200.00
