# Access Compliance Report

## Public Rights-of-Way

### (Curb Ramps)

Intersection ID: 13466	Main Street: BAY_ST	Cross Street: HAWTHORNE_LN	Location: E
ADA ID: 7D550DD68E21	Ramp Type: PerpDiag	Initial Pass/Fail: Fail	Overall Compliance: No
Codes/Mitigation Info/Possible Solution		Field Measurements/Component Compliance	
Severity Score: 46.25

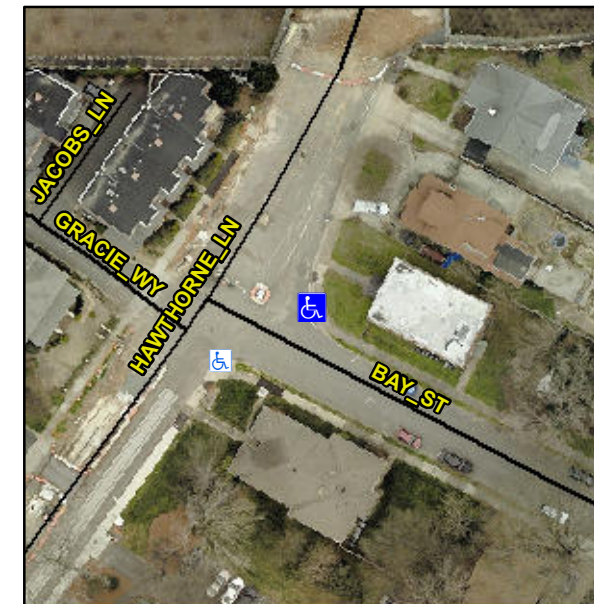
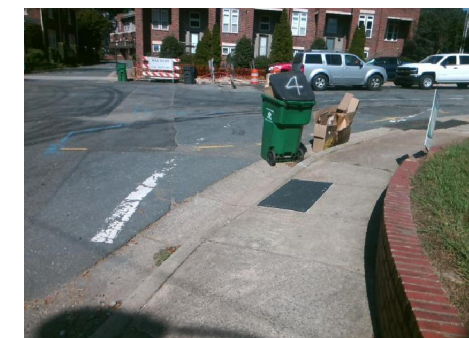
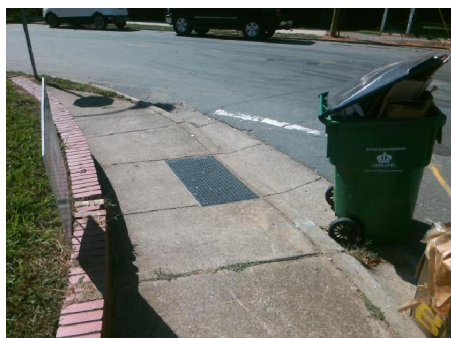
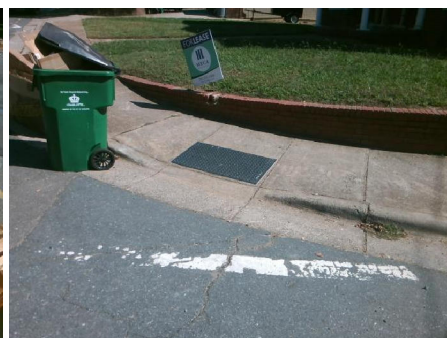
**Not Found, R304.5.1, R304.2.2, R304.5.3**

Compliance	Description	Data	Compliance	Description	Data
N/A	Ramp Length (in)	59.0	No	Ramp Slope (%)	12.3
No	Ramp Width (in)	46.0	No	Ramp XSlope (%)	5.3
N/A	Flare Type LT	N/A	N/A	Flare Type RT	N/A
N/A	Flare Slope LT (%)	N/A	N/A	Flare Slope RT (%)	N/A
N/A	Flare Traversable LT?	N/A	N/A	Flare Traversable RT?	N/A
N/A	Landing Length (in)	N/A	N/A	DWS Provided?	N/A
N/A	Landing Width (in)	N/A	N/A	DWS Contrast?	N/A
N/A	Landing Slope (%)	N/A	N/A	DWS Length (in)	N/A
N/A	Landing X Slope (%)	N/A	N/A	DWS Full Width?	N/A
N/A	Landing Curb? (Y/N)	N/A	N/A	DWS Offset (in)	N/A
N/A	Shared Landing?	N/A			
N/A	Gutter Ponding?	N/A	N/A	Gutter Slope (%)	N/A
N/A	Gutter Lip Ht (in)	N/A	N/A	Gutter X Slope (%)	N/A
N/A	Painted X Walk1?	No	N/A	Painted X Walk2?	No
	X Walk 1 Direction	To NW		X Walk 2 Direction	To SW
N/A	X Walk 1 Width (in)	N/A	N/A	X Walk 2 Width (in)	N/A
	X Walk 1 Slope (%)	4.9		X Walk 2 Slope (%)	3.7
	X Walk 1 X Slope (%)	3.0		X Walk 2 X Slope (%)	5.0

N/A	Ramp inside XWalk1?	N/A	N/A	Ramp inside XWalk2?	N/A
	Road Slope (%)	3.6	N/A	Clear Space?	N/A
	Road X Slope (%)	5.2	N/A	Clear Space to XWalk (in)	N/A
N/A	Any Obstructions?	N/A	N/A	Storm Grate/Utility Hazard?	N/A
	Obstruction Type			Storm Grate/Utility Type	
		N/A			N/A
			Yes	Surface Condition? (G/P)	Good

**Remove & Replace Curb Ramp With Two New Directional Ramps or Equivalent.**
