Intersection ID: 10024131	Main Street: COULOAK_DR	Cross Street: N/A	Location:	E
ADA ID: 7D5A4BFF52AA	Ramp Type: Perp	Initial Pass/Fail: Fail	Overall Compliance: No	Severity Score: 8.75

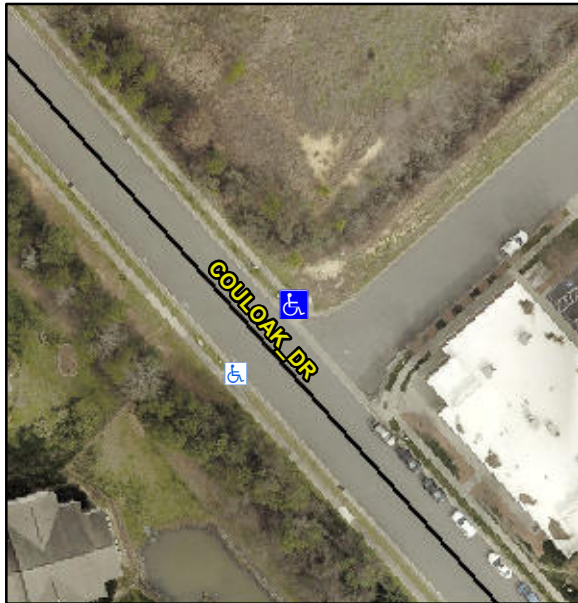
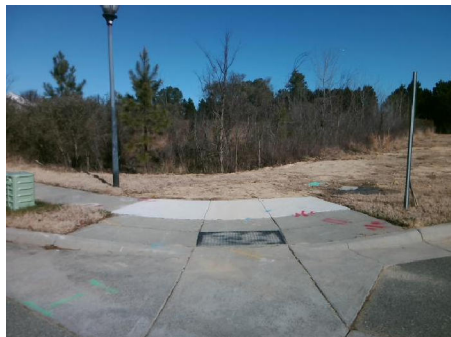
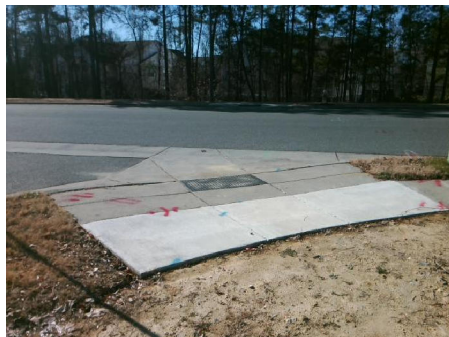
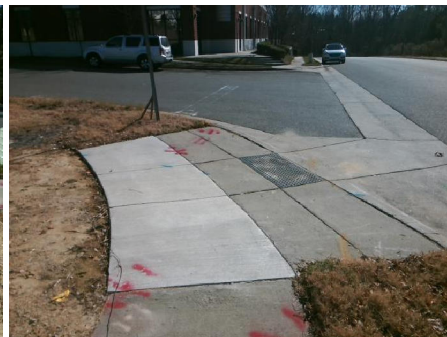
Compliance	Description	Data	Compliance	Description	Data
N/A	Ramp Length (in)	52.0	Yes	Ramp Slope (%)	5.1
No	Ramp Width (in)	45.0	Yes	Ramp XSlope (%)	0.7
N/A	Flare Type LT	N/A	N/A	Flare Type RT	N/A
N/A	Flare Slope LT (%)	N/A	N/A	Flare Slope RT (%)	N/A
N/A	Flare Traversable LT?	N/A	N/A	Flare Traversable RT?	N/A
N/A	Landing Length (in)	N/A	N/A	DWS Provided?	N/A
N/A	Landing Width (in)	N/A	N/A	DWS Contrast?	N/A
N/A	Landing Slope (%)	N/A	N/A	DWS Length (in)	N/A
N/A	Landing X Slope (%)	N/A	N/A	DWS Full Width?	N/A
N/A	Landing Curb? (Y/N)	N/A	N/A	DWS Offset (in)	N/A
N/A	Shared Landing?	N/A			
N/A	Gutter Ponding?	N/A	N/A	Gutter Slope (%)	N/A
N/A	Gutter Lip Ht (in)	N/A	N/A	Gutter X Slope (%)	N/A
N/A	Painted X Walk1?	No	N/A	Painted X Walk2?	N/A
	X Walk 1 Direction	To SW		X Walk 2 Direction	N/A
N/A	X Walk 1 Width (in)	N/A	N/A	X Walk 2 Width (in)	N/A
	X Walk 1 Slope (%)	3.3		X Walk 2 Slope (%)	N/A
	X Walk 1 X Slope (%)	1.9		X Walk 2 X Slope (%)	N/A

N/A	Ramp inside XWalk1?	N/A	N/A	Ramp inside XWalk2?	N/A
	Road Slope (%)	N/A	N/A	Clear Space?	N/A
	Road X Slope (%)	N/A	N/A	Clear Space to XWalk (in)	N/A
N/A	Any Obstructions?	N/A	N/A	Storm Grate/Utility Hazard?	N/A
	Obstruction Type			Storm Grate/Utility Type	
		N/A			N/A
			Yes	Surface Condition? (G/P)	Good

Remove & Replace Entire Ramp.

R304.5.1
