Access Compliance Report

Public Rights-of-Way

(Curb Ramps)

Intersection ID: 28651	Main Street: MARVIN_RD	Cross Street: PRINCETON_COMMONS_DR	Location: NE
ADA ID: 7D5E4C690800	Ramp Type: Perp	Initial Pass/Fail: Fail	Overall Compliance: No
Severity Score: 42.5			
Codes/Mitigation Info/Possible Solution		Field Measurements/Component Compliance

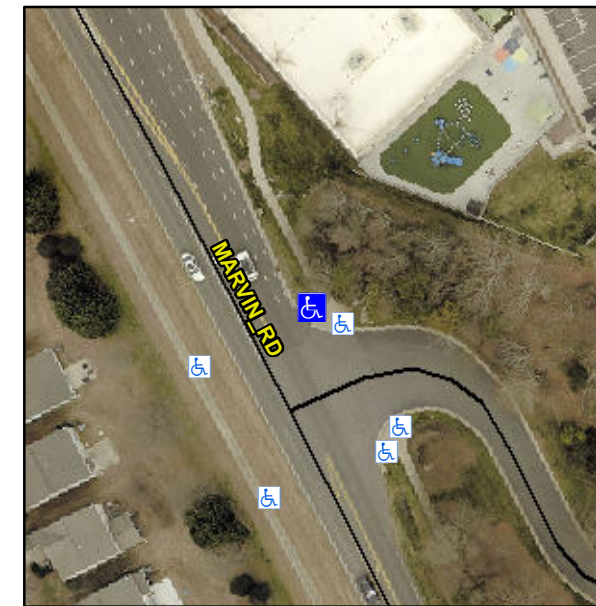
Compliance	Description	Data	Compliance	Description	Data
N/A	Ramp Length (in)	137.0	Yes	Ramp Slope (%)	7.7
No	Ramp Width (in)	33.0	No	Ramp XSlope (%)	9.6
N/A	Flare Type LT	N/A	N/A	Flare Type RT	N/A
N/A	Flare Slope LT (%)	N/A	N/A	Flare Slope RT (%)	N/A
N/A	Flare Traversable LT?	N/A	N/A	Flare Traversable RT?	N/A
N/A	Landing Length (in)	N/A	N/A	DWS Provided?	N/A
N/A	Landing Width (in)	N/A	N/A	DWS Contrast?	N/A
N/A	Landing Slope (%)	N/A	N/A	DWS Length (in)	N/A
N/A	Landing X Slope (%)	N/A	N/A	DWS Full Width?	N/A
N/A	Landing Curb? (Y/N)	N/A	N/A	DWS Offset (in)	N/A
N/A	Shared Landing?	N/A			
N/A	Gutter Ponding?	N/A	N/A	Gutter Slope (%)	N/A
N/A	Gutter Lip Ht (in)	N/A	N/A	Gutter X Slope (%)	N/A
N/A	Painted X Walk1?	No	N/A	Painted X Walk2?	N/A
	X Walk 1 Direction	To SW		X Walk 2 Direction	N/A
N/A	X Walk 1 Width (in)	N/A	N/A	X Walk 2 Width (in)	N/A
	X Walk 1 Slope (%)	5.8		X Walk 2 Slope (%)	N/A
	X Walk 1 X Slope (%)	4.8		X Walk 2 X Slope (%)	N/A

N/A	Ramp inside XWalk1?	N/A	N/A	Ramp inside XWalk2?	N/A
	Road Slope (%)	N/A	N/A	Clear Space?	N/A
	Road X Slope (%)	N/A	N/A	Clear Space to XWalk (in)	N/A
N/A	Any Obstructions?	N/A	N/A	Storm Grate/Utility Hazard?	N/A
	Obstruction Type			Storm Grate/Utility Type	
		N/A			N/A
			Yes	Surface Condition? (G/P)	Good

Possible Solutions:

Remove & Replace Entire Ramp.

R304.5.1, R304.5.3

Total Cost: \$ 1850.00
