# Access Compliance Report

## Public Rights-of-Way

### (Curb Ramps)

Intersection ID: 50616	Main Street: PADDLE_OAK_RD	Cross Street: FAWN_LILY	Location: SE
ADA ID: 7D5F822B34D5	Ramp Type: Perp	Initial Pass/Fail: Fail	Overall Compliance: No
Severity Score: 13.75			
Codes/Mitigation Info/Possible Solution		Field Measurements/Component Compliance

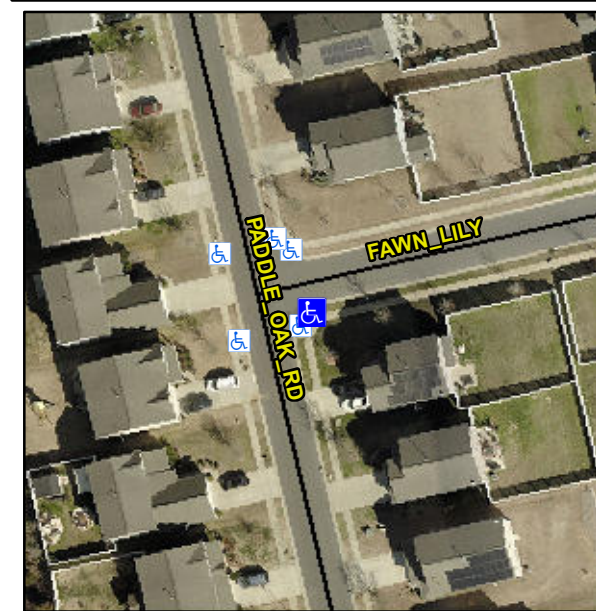
Compliance	Description	Data	Compliance	Description	Data
N/A	Ramp Length (in)	48.0	No	Ramp Slope (%)	8.7
Yes	Ramp Width (in)	48.0	No	Ramp XSlope (%)	4.6
N/A	Flare Type LT	N/A	N/A	Flare Type RT	N/A
N/A	Flare Slope LT (%)	N/A	N/A	Flare Slope RT (%)	N/A
N/A	Flare Traversable LT?	N/A	N/A	Flare Traversable RT?	N/A
N/A	Landing Length (in)	N/A	N/A	DWS Provided?	N/A
N/A	Landing Width (in)	N/A	N/A	DWS Contrast?	N/A
N/A	Landing Slope (%)	N/A	N/A	DWS Length (in)	N/A
N/A	Landing X Slope (%)	N/A	N/A	DWS Full Width?	N/A
N/A	Landing Curb? (Y/N)	N/A	N/A	DWS Offset (in)	N/A
N/A	Shared Landing?	N/A			
N/A	Gutter Ponding?	N/A	N/A	Gutter Slope (%)	N/A
N/A	Gutter Lip Ht (in)	N/A	N/A	Gutter X Slope (%)	N/A
N/A	Painted X Walk1?	No	N/A	Painted X Walk2?	N/A
	X Walk 1 Direction	To N		X Walk 2 Direction	N/A
N/A	X Walk 1 Width (in)	N/A	N/A	X Walk 2 Width (in)	N/A
	X Walk 1 Slope (%)	1.3		X Walk 2 Slope (%)	N/A
	X Walk 1 X Slope (%)	2.6		X Walk 2 X Slope (%)	N/A

N/A	Ramp inside XWalk1?	N/A	N/A	Ramp inside XWalk2?	N/A
	Road Slope (%)	N/A	N/A	Clear Space?	N/A
	Road X Slope (%)	N/A	N/A	Clear Space to XWalk (in)	N/A
N/A	Any Obstructions?	N/A	N/A	Storm Grate/Utility Hazard?	N/A
	Obstruction Type			Storm Grate/Utility Type	
		N/A			N/A
			Yes	Surface Condition? (G/P)	Good

Possible Solutions:

**Remove & Replace Entire Ramp.**

PROW/ADA:

**R304.2.2, R304.5.3**

Total Cost: \$ 1850.00
