Access Compliance Report

Public Rights-of-Way

(Curb Ramps)

Intersection ID: 8367	Main Street: KENTUCKY_AV	Cross Street: NELSON_AV	Location: SW
ADA ID: 7D60419D49D5	Ramp Type: Perp	Initial Pass/Fail: Fail	Overall Compliance: No
		Severity Score: 10

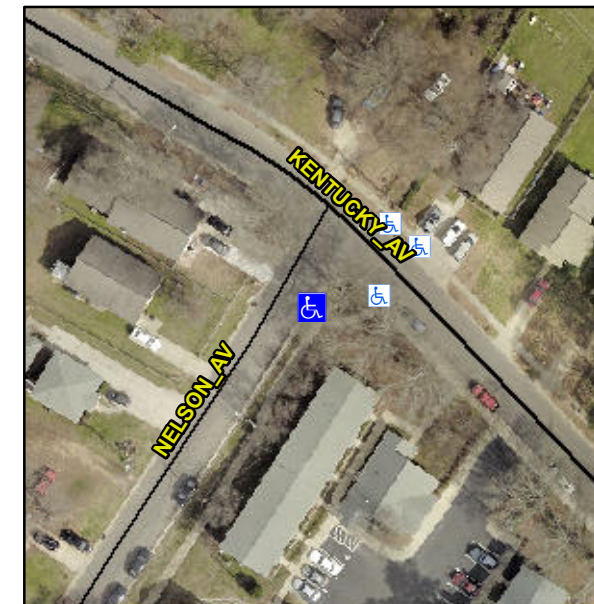
Not Found, R304.5.1, R304.5.3

Compliance	Description	Data	Compliance	Description	Data
N/A	Ramp Length (in)	107.0	Yes	Ramp Slope (%)	5.1
No	Ramp Width (in)	44.5	No	Ramp XSlope (%)	3.9
N/A	Flare Type LT	N/A	N/A	Flare Type RT	N/A
N/A	Flare Slope LT (%)	N/A	N/A	Flare Slope RT (%)	N/A
N/A	Flare Traversable LT?	N/A	N/A	Flare Traversable RT?	N/A
N/A	Landing Length (in)	N/A	N/A	DWS Provided?	N/A
N/A	Landing Width (in)	N/A	N/A	DWS Contrast?	N/A
N/A	Landing Slope (%)	N/A	N/A	DWS Length (in)	N/A
N/A	Landing X Slope (%)	N/A	N/A	DWS Full Width?	N/A
N/A	Landing Curb? (Y/N)	N/A	N/A	DWS Offset (in)	N/A
N/A	Shared Landing?	N/A			
N/A	Gutter Ponding?	N/A	N/A	Gutter Slope (%)	N/A
N/A	Gutter Lip Ht (in)	N/A	N/A	Gutter X Slope (%)	N/A
N/A	Painted X Walk1?	No	N/A	Painted X Walk2?	N/A
	X Walk 1 Direction	To W		X Walk 2 Direction	N/A
N/A	X Walk 1 Width (in)	N/A	N/A	X Walk 2 Width (in)	N/A
	X Walk 1 Slope (%)	1.4		X Walk 2 Slope (%)	N/A
	X Walk 1 X Slope (%)	6.6		X Walk 2 X Slope (%)	N/A

N/A	Ramp inside XWalk1?	N/A	N/A	Ramp inside XWalk2?	N/A
	Road Slope (%)	6.6	N/A	Clear Space?	N/A
	Road X Slope (%)	1.4	N/A	Clear Space to XWalk (in)	N/A
N/A	Any Obstructions?	N/A	N/A	Storm Grate/Utility Hazard?	N/A
	Obstruction Type			Storm Grate/Utility Type	
		N/A			N/A
		Yes		Surface Condition? (G/P)	Good

Remove & Replace Entire Ramp.
