# Access Compliance Report

## Public Rights-of-Way

### (Curb Ramps)

Intersection ID: 5563	Main Street: N I-77 EXIT 16 RA	Cross Street: REAMES_RD	Location: SE
ADA ID: 7D666CD706BE	Ramp Type: Directional1	Initial Pass/Fail: Pass	Overall Compliance: Yes
Severity Score: 0			
Codes/Mitigation Info/Possible Solution		Field Measurements/Component Compliance

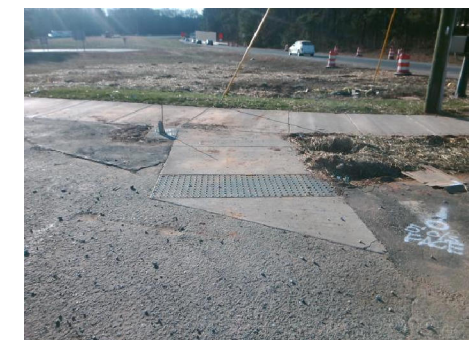
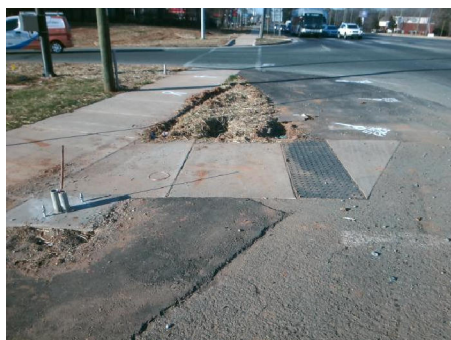
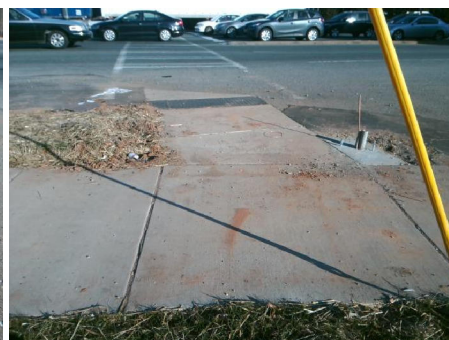
Compliance	Description	Data	Compliance	Description	Data
N/A	Ramp Length (in)	135.0	Yes	Grade Break?	Yes
Yes	Ramp Width (in)	72.0	Yes	Grade Break Slope (%)	0.8
Yes	Ramp Slope (%)	4.4	Yes	Grade Break XSlope (%)	1.5
Yes	Ramp XSlope (%)	1.6			
N/A	Flare Type LT	N/A	N/A	Flare Type RT	N/A
N/A	Flare Slope LT (%)	N/A	N/A	Flare Slope RT (%)	N/A
N/A	Flare Traversable LT?	N/A	N/A	Flare Traversable RT?	N/A
Yes	Landing Length (in)	72.0	Yes	DWS Provided?	Yes
Yes	Landing Width (in)	69.0	Yes	DWS Contrast?	Yes
Yes	Landing Slope (%)	0.8	Yes	DWS Length (in)	24.0
Yes	Landing X Slope (%)	1.3	Yes	DWS Full Width?	Yes
N/A	Landing Curb? (Y/N)	No	Yes	DWS Offset LT (in)	0.0
N/A	Shared Landing?	No	Yes	DWS Offset RT (in)	39.0
Yes	Gutter Ponding?	No	Yes	Gutter Slope (%)	1.8
Yes	Gutter Lip Ht (in)	0.0	Yes	Gutter X Slope (%)	1.1
N/A	Painted X Walk1?	Yes		Road Slope (%)	1.6
	X Walk 1 Direction	To N		Road X Slope (%)	4.1
	X Walk 1 Width (in)	112.0		Clear Space?	Yes

X Walk 1 Slope (%)	1.6	N/A	Clear Space to XWalk (in)	N/A
	X Walk 1 X Slope (%)	4.1	Yes	Storm Grate/Utility Hazard?	No
Yes	Ramp inside XWalk1?	Yes		Storm Grate/Utility Type	
Yes	Any Obstructions?	No			N/A
	Obstruction Type		Yes	Surface Condition? (G/P)	Good
			N/A	Curb Slope (%)	4.6
