Access Compliance Report

Public Rights-of-Way

(Curb Ramps)

Intersection ID: 31473	Main Street: ALSTON_HILL_DR	Cross Street: EMERALD_FERN_WY	Location: NE
ADA ID: 7D66F13FD7E7	Ramp Type: BlendTrans1	Initial Pass/Fail: Fail	Overall Compliance: No
		Severity Score: 25

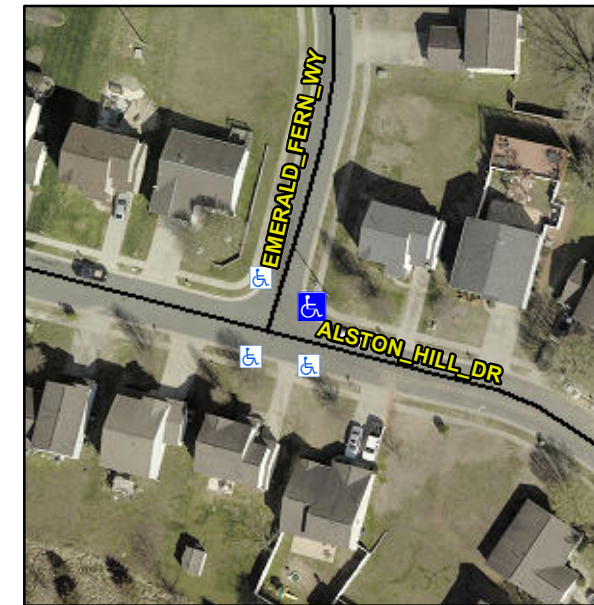
Compliance	Description	Data	Compliance	Description	Data
N/A	Ramp Length (in)	48.0	Yes	BlendTrans Slope (%)	4.7
Yes	Ramp Width (in)	48.5	No	BlendTrans XSlope (%)	7.5
N/A	Flare Type LT	N/A	N/A	Flare Type RT	N/A
N/A	Flare Slope LT (%)	N/A	N/A	Flare Slope RT (%)	N/A
N/A	Flare Traversable LT?	N/A	N/A	Flare Traversable RT?	N/A
N/A	Landing Length (in)	N/A	N/A	DWS Provided?	N/A
N/A	Landing Width (in)	N/A	N/A	DWS Contrast?	N/A
N/A	Landing Slope (%)	N/A	N/A	DWS Length (in)	N/A
N/A	Landing X Slope (%)	N/A	N/A	DWS Full Width?	N/A
N/A	Landing Curb? (Y/N)	N/A	N/A	DWS Offset (in)	N/A
N/A	Shared Landing?	N/A			
N/A	Gutter Ponding?	N/A	N/A	Gutter Slope (%)	N/A
N/A	Gutter Lip Ht (in)	N/A	N/A	Gutter X Slope (%)	N/A
N/A	Painted X Walk1?	No	N/A	Painted X Walk2?	No
	X Walk 1 Direction	To W		X Walk 2 Direction	To S
	X Walk 1 Width (in)	N/A		X Walk 2 Width (in)	N/A
	X Walk 1 Slope (%)	1.8		X Walk 2 Slope (%)	4.0
	X Walk 1 X Slope (%)	4.8		X Walk 2 X Slope (%)	4.0

N/A	Ramp inside XWalk1?	N/A	N/A	Ramp inside XWalk2?	N/A
	Road Slope (%)	8.0		Clear Space?	N/A
	Road X Slope (%)	2.0	N/A	Clear Space to XWalk (in)	N/A
N/A	Any Obstructions?	N/A	N/A	Storm Grate/Utility Hazard?	N/A
	Obstruction Type			Storm Grate/Utility Type	
		N/A			N/A
			Yes	Surface Condition? (G/P)	Good
			No	Curb Slope (%)	9.3

Remove & Replace Curb Ramp With Two New Directional Ramps or Equivalent.

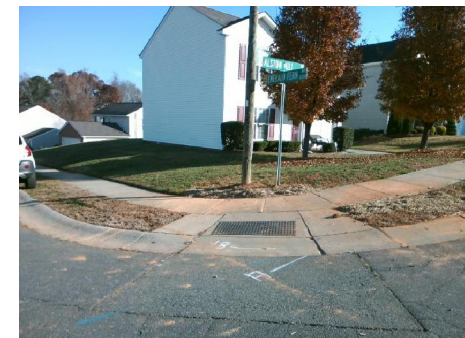
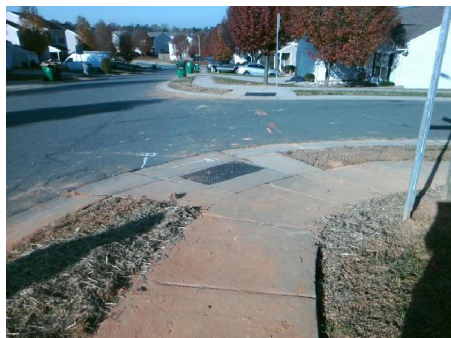
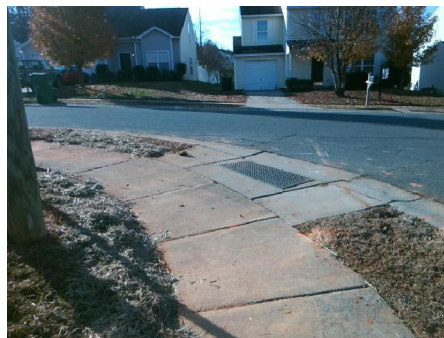
Not Found, R304.5.3
