# Access Compliance Report

## Public Rights-of-Way

### (Curb Ramps)

| Intersection ID: 14278 | Main Street: ROMARE_BEARDEN_DR | Cross Street: FARMER_ST | Location: | N |

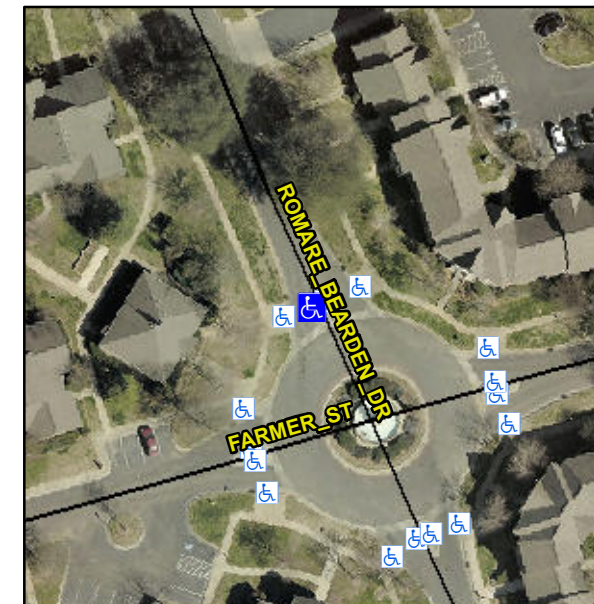
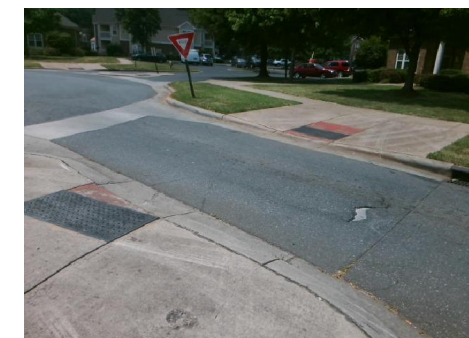
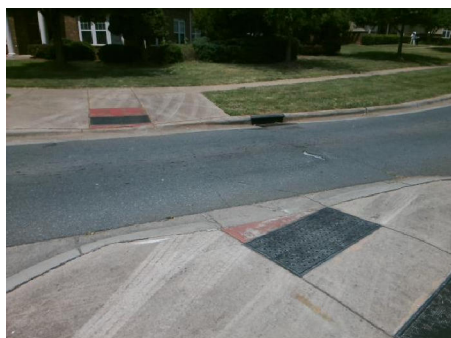
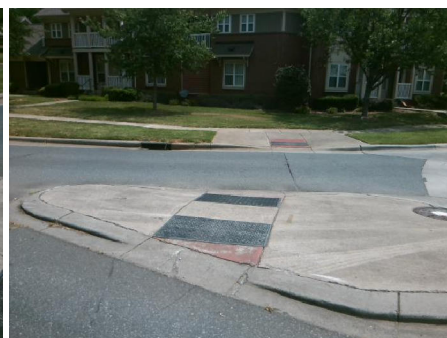
| ADA ID: 7D7B350AD3D1 | Ramp Type: MedianPerp | Initial Pass/Fail: Fail | Overall Compliance: No | Severity Score: 1.25 |

**Not Found, R304.5.3**

| Compliance | Description | Data | Compliance | Description | Data |
|---|---|---|---|---|---|
| N/A | Ramp Length (in) | 37.0 | Yes | Ramp Slope (%) | 5.8 |
| Yes | Ramp Width (in) | 48.0 | No | Ramp XSlope (%) | 2.4 |

**Remove & Replace Entire Ramp.**
