# Access Compliance Report

## Public Rights-of-Way

### (Curb Ramps)

| Intersection ID: 27404 | Main Street: BALLANTYNE COMMONS PY | Cross Street: MEADOW RUN LN | Location: | NW |

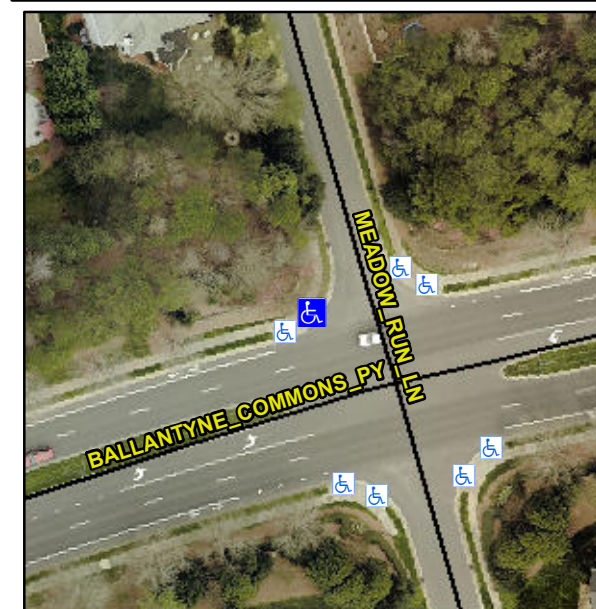
| ADA ID: 7D7F1C0FC359 | Ramp Type: Perp | Initial Pass/Fail: Fail | Overall Compliance: No | Severity Score: 10 |

**Not Found, R304.5.1, R304.5.3**

| Compliance | Description | Data | Compliance | Description | Data |
|---|---|---|---|---|---|
| N/A | Ramp Length (in) | 105.0 | Yes | Ramp Slope (%) | 7.9 |
| No | Ramp Width (in) | 37.0 | No | Ramp XSlope (%) | 2.9 |

**Remove & Replace Entire Ramp.**
