Access Compliance Report

Public Rights-of-Way

(Curb Ramps)

Intersection ID: 47611	Main Street: WYALONG_DR	Cross Street: MINTWORTH_AV	Location: SE
ADA ID: 7D82652778F8	Ramp Type: Perp	Initial Pass/Fail: Fail	Overall Compliance: No
Severity Score: 12.5			
Codes/Mitigation Info/Possible Solution		Field Measurements/Component Compliance

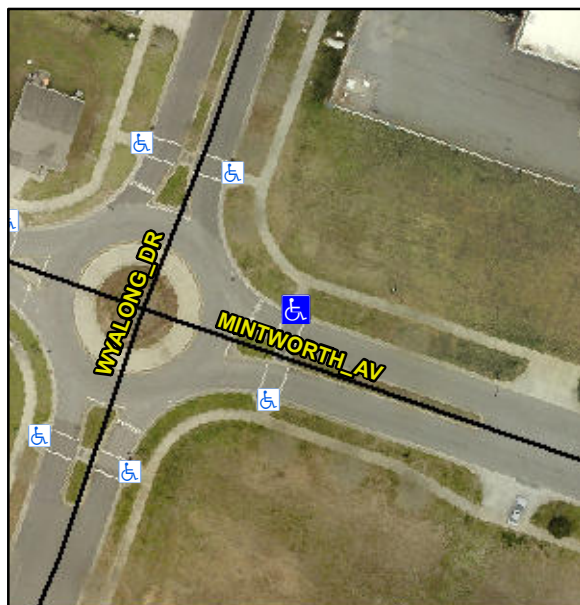
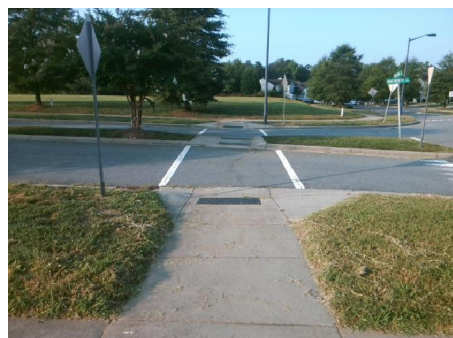
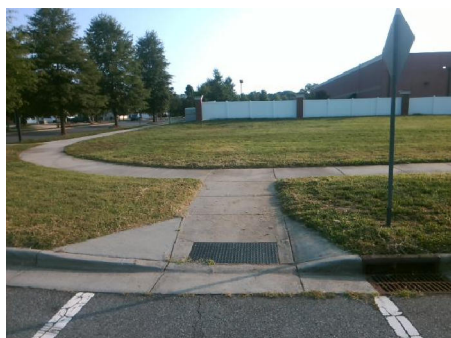
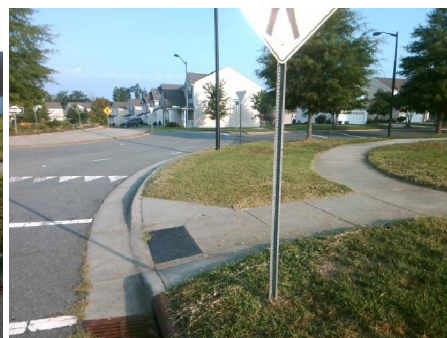
Not Found, R304.2.2

Compliance	Description	Data	Compliance	Description	Data
N/A	Ramp Length (in)	73.0	No	Ramp Slope (%)	10.4
Yes	Ramp Width (in)	69.0	Yes	Ramp XSlope (%)	1.2
N/A	Flare Type LT	N/A	N/A	Flare Type RT	N/A
N/A	Flare Slope LT (%)	N/A	N/A	Flare Slope RT (%)	N/A
N/A	Flare Traversable LT?	N/A	N/A	Flare Traversable RT?	N/A
N/A	Landing Length (in)	N/A	N/A	DWS Provided?	N/A
N/A	Landing Width (in)	N/A	N/A	DWS Contrast?	N/A
N/A	Landing Slope (%)	N/A	N/A	DWS Length (in)	N/A
N/A	Landing X Slope (%)	N/A	N/A	DWS Full Width?	N/A
N/A	Landing Curb? (Y/N)	N/A	N/A	DWS Offset (in)	N/A
N/A	Shared Landing?	N/A			
N/A	Gutter Ponding?	N/A	N/A	Gutter Slope (%)	N/A
N/A	Gutter Lip Ht (in)	N/A	N/A	Gutter X Slope (%)	N/A
N/A	Painted X Walk1?	Yes	N/A	Painted X Walk2?	N/A
	X Walk 1 Direction	To SW		X Walk 2 Direction	N/A
N/A	X Walk 1 Width (in)	120.0	N/A	X Walk 2 Width (in)	N/A
	X Walk 1 Slope (%)	4.1		X Walk 2 Slope (%)	N/A
	X Walk 1 X Slope (%)	0.8		X Walk 2 X Slope (%)	N/A

N/A	Ramp inside XWalk1?	Yes	N/A	Ramp inside XWalk2?	N/A
	Road Slope (%)	N/A	N/A	Clear Space?	N/A
	Road X Slope (%)	N/A	N/A	Clear Space to XWalk (in)	N/A
N/A	Any Obstructions?	N/A	N/A	Storm Grate/Utility Hazard?	N/A
	Obstruction Type			Storm Grate/Utility Type	
		N/A			N/A
		Yes		Surface Condition? (G/P)	Good

Remove & Replace Entire Ramp.

Total Cost: \$ 1850.00
