Access Compliance Report

Public Rights-of-Way

(Curb Ramps)

Intersection ID: 18287	Main Street: BEECHDALE_DR	Cross Street: MCLAUGHLIN_DR	Location: NW
ADA ID: 7D86EA7C0665	Ramp Type: BlendTrans1	Initial Pass/Fail: Fail	Overall Compliance: No
Severity Score: 18.75			
Codes/Mitigation Info/Possible Solution		Field Measurements/Component Compliance

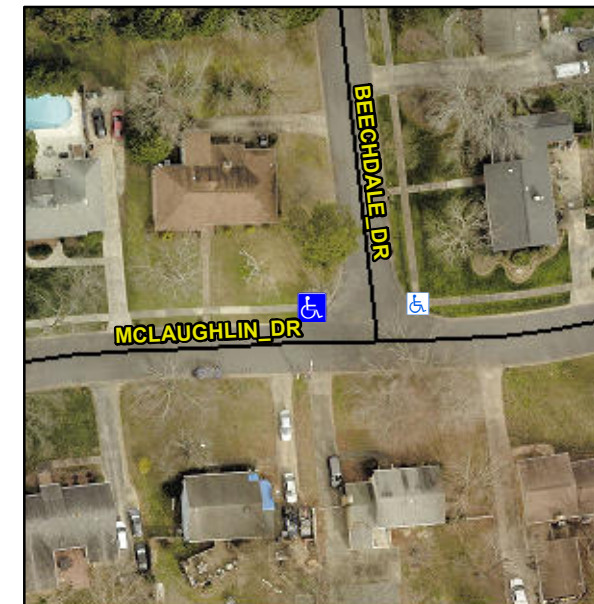
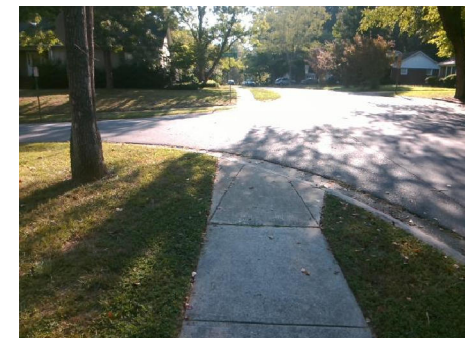
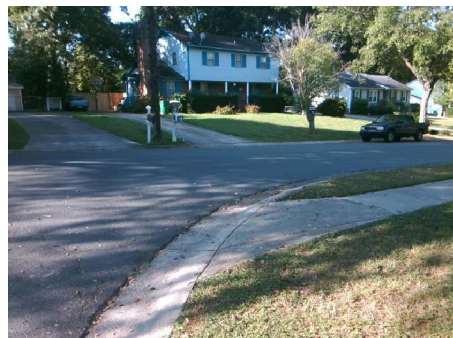
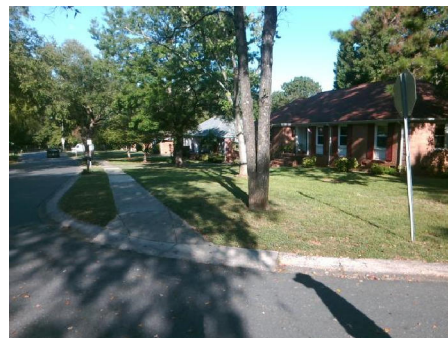
ASP LIP 1.0

Not Found, R304.5.1, R304.5.3

Compliance	Description	Data	Compliance	Description	Data
N/A	Ramp Length (in)	80.0	Yes	BlendTrans Slope (%)	0.3
No	Ramp Width (in)	34.0	No	BlendTrans XSlope (%)	4.6
N/A	Flare Type LT	N/A	N/A	Flare Type RT	N/A
N/A	Flare Slope LT (%)	N/A	N/A	Flare Slope RT (%)	N/A
N/A	Flare Traversable LT?	N/A	N/A	Flare Traversable RT?	N/A
N/A	Landing Length (in)	N/A	N/A	DWS Provided?	N/A
N/A	Landing Width (in)	N/A	N/A	DWS Contrast?	N/A
N/A	Landing Slope (%)	N/A	N/A	DWS Length (in)	N/A
N/A	Landing X Slope (%)	N/A	N/A	DWS Full Width?	N/A
N/A	Landing Curb? (Y/N)	N/A	N/A	DWS Offset (in)	N/A
N/A	Shared Landing?	N/A			
N/A	Gutter Ponding?	N/A	N/A	Gutter Slope (%)	N/A
N/A	Gutter Lip Ht (in)	N/A	N/A	Gutter X Slope (%)	N/A
N/A	Painted X Walk1?	No	N/A	Painted X Walk2?	No
	X Walk 1 Direction	To S		X Walk 2 Direction	To E
	X Walk 1 Width (in)	N/A		X Walk 2 Width (in)	N/A
	X Walk 1 Slope (%)	2.4		X Walk 2 Slope (%)	6.8
	X Walk 1 X Slope (%)	2.5		X Walk 2 X Slope (%)	3.6

N/A	Ramp inside XWalk1?	N/A	N/A	Ramp inside XWalk2?	N/A
	Road Slope (%)	2.2		Clear Space?	N/A
	Road X Slope (%)	5.3	N/A	Clear Space to XWalk (in)	N/A
N/A	Any Obstructions?	N/A	N/A	Storm Grate/Utility Hazard?	N/A
	Obstruction Type			Storm Grate/Utility Type	
		N/A			N/A
			Yes	Surface Condition? (G/P)	Good
			No	Curb Slope (%)	11.8

Possible Solutions:

Remove & Replace Curb Ramp With Two New Directional Ramps or Equivalent.

Total Cost: \$ 3200.00
