# Access Compliance Report

## Public Rights-of-Way

### (Curb Ramps)

Intersection ID: 8746	Main Street: GENERAL_COMMERCE_DR	Cross Street: INDUSTRIAL_CENTER_CR	Location: S
ADA ID: 7D9A0AD47F52	Ramp Type: Perp	Initial Pass/Fail: Fail	Overall Compliance: No
Severity Score: 12.5			
Codes/Mitigation Info/Possible Solution		Field Measurements/Component Compliance

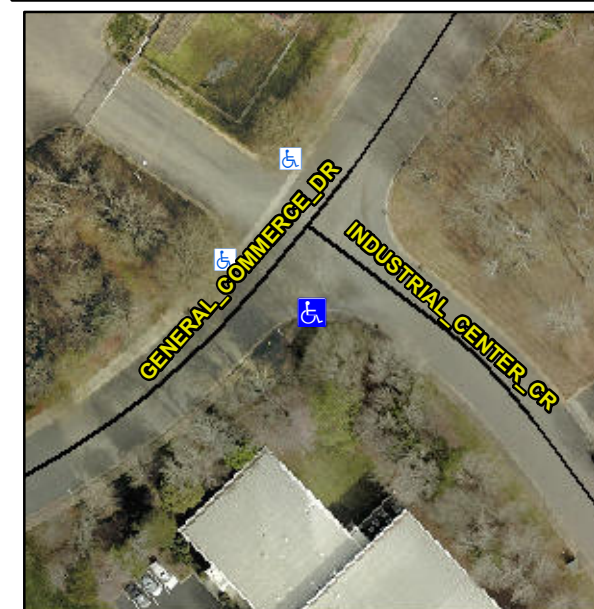
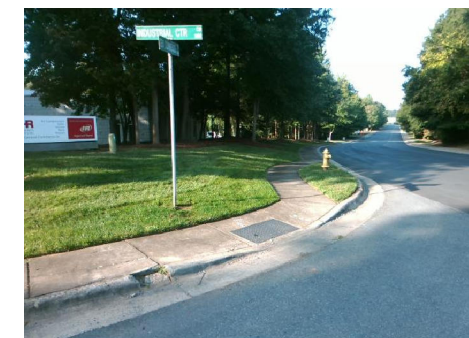
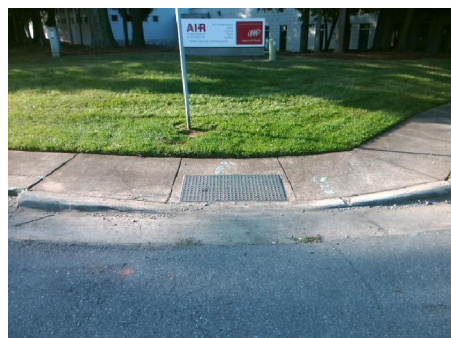
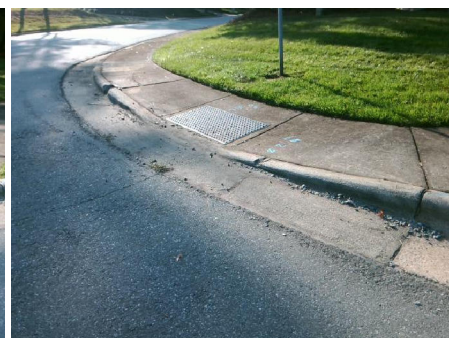
Compliance	Description	Data	Compliance	Description	Data
N/A	Ramp Length (in)	47.5	No	Ramp Slope (%)	10.5
Yes	Ramp Width (in)	52.0	Yes	Ramp XSlope (%)	0.6
N/A	Flare Type LT	N/A	N/A	Flare Type RT	N/A
N/A	Flare Slope LT (%)	N/A	N/A	Flare Slope RT (%)	N/A
N/A	Flare Traversable LT?	N/A	N/A	Flare Traversable RT?	N/A
N/A	Landing Length (in)	N/A	N/A	DWS Provided?	N/A
N/A	Landing Width (in)	N/A	N/A	DWS Contrast?	N/A
N/A	Landing Slope (%)	N/A	N/A	DWS Length (in)	N/A
N/A	Landing X Slope (%)	N/A	N/A	DWS Full Width?	N/A
N/A	Landing Curb? (Y/N)	N/A	N/A	DWS Offset (in)	N/A
N/A	Shared Landing?	N/A			
N/A	Gutter Ponding?	N/A	N/A	Gutter Slope (%)	N/A
N/A	Gutter Lip Ht (in)	1.0	N/A	Gutter X Slope (%)	N/A
N/A	Painted X Walk1?	No	N/A	Painted X Walk2?	N/A
	X Walk 1 Direction	To NW		X Walk 2 Direction	N/A
N/A	X Walk 1 Width (in)	N/A	N/A	X Walk 2 Width (in)	N/A
	X Walk 1 Slope (%)	2.8		X Walk 2 Slope (%)	N/A
	X Walk 1 X Slope (%)	1.8		X Walk 2 X Slope (%)	N/A

N/A	Ramp inside XWalk1?	N/A	N/A	Ramp inside XWalk2?	N/A
	Road Slope (%)	N/A	N/A	Clear Space?	N/A
	Road X Slope (%)	N/A	N/A	Clear Space to XWalk (in)	N/A
N/A	Any Obstructions?	N/A	N/A	Storm Grate/Utility Hazard?	N/A
	Obstruction Type			Storm Grate/Utility Type	
		N/A			N/A
			Yes	Surface Condition? (G/P)	Good

**Remove & Replace Entire Ramp.**

**R304.2.2**

**\$ 1850.00**
