Access Compliance Report

Public Rights-of-Way

(Curb Ramps)

Intersection ID: 19122	Main Street: AMRITA_CT	Cross Street: RANDOLPH_RD	Location: NW
ADA ID: 7DA187F27FE4	Ramp Type: Directional1	Initial Pass/Fail: Fail	Overall Compliance: No
		Severity Score: 1.25

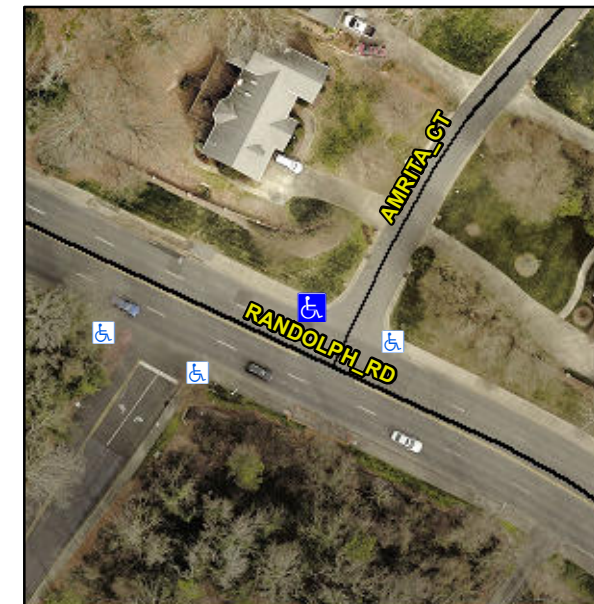
Compliance	Description	Data	Compliance	Description	Data
N/A	Ramp Length (in)	63.0	N/A	Grade Break?	N/A
Yes	Ramp Width (in)	48.0	N/A	Grade Break Slope (%)	0.0
Yes	Ramp Slope (%)	1.4	N/A	Grade Break XSlope (%)	0.0
No	Ramp XSlope (%)	3.3			
N/A	Flare Type LT	N/A	N/A	Flare Type RT	N/A
N/A	Flare Slope LT (%)	N/A	N/A	Flare Slope RT (%)	0.0
N/A	Flare Traversable LT?	N/A	N/A	Flare Traversable RT?	N/A
N/A	Landing Length (in)	0.0	N/A	DWS Provided?	N/A
N/A	Landing Width (in)	0.0	N/A	DWS Contrast?	N/A
N/A	Landing Slope (%)	0.0	N/A	DWS Length (in)	N/A
N/A	Landing X Slope (%)	0.0	N/A	DWS Full Width?	N/A
N/A	Landing Curb? (Y/N)	N/A	N/A	DWS Offset LT (in)	N/A
N/A	Shared Landing?	N/A	N/A	DWS Offset RT (in)	N/A
N/A	Gutter Ponding?	0.0	N/A	Gutter Slope (%)	N/A
N/A	Gutter Lip Ht (in)	0.0	N/A	Gutter X Slope (%)	N/A
N/A	Painted X Walk1?	No		Road Slope (%)	5.0
	X Walk 1 Direction	To E		Road X Slope (%)	6.0
	X Walk 1 Width (in)	N/A		Clear Space?	N/A

X Walk 1 Slope (%)	5.0	N/A	Clear Space to XWalk (in)	N/A
	X Walk 1 X Slope (%)	6.0	N/A	Storm Grate/Utility Hazard?	N/A
N/A	Ramp inside XWalk1?	N/A		Storm Grate/Utility Type	
N/A	Any Obstructions?	N/A			N/A
	Obstruction Type		Yes	Surface Condition? (G/P)	Good
			N/A	Curb Slope (%)	27.0

Possible Solutions:

Remove & Replace Entire Ramp.

R304.5.3

\$ 1600.00
