## **Access Compliance Report Public Rights-of-Way** (Curb Ramps)

Intersection ID: 8500 Main Street: ERIE\_ST **Cross Street: LASALLE ST** Location: NE

**Overall Compliance: No** ADA ID: 7DA1D2DF0D7A Ramp Type: PerpDiag Initial Pass/Fail: Fail **Severity Score:** 8.75

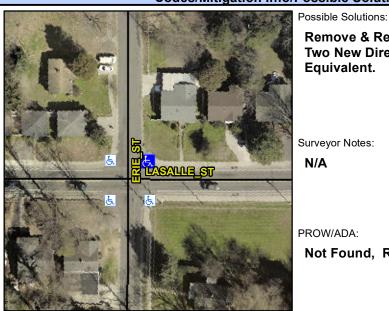
Compliance Description		Data	Compliance		Description	Data
N/A	Ramp Length (in)	57.5	Yes	Ramp	Slope (%)	7.7
No	Ramp Width (in)	46.0	Yes	Ramp	XSlope (%)	0.7
N/A	Flare Type LT	N/A	N/A	Flare	Type RT	N/A
N/A	Flare Slope LT (%)	N/A	N/A	Flare	Slope RT (%)	N/A
N/A	Flare Traversable LT?	N/A	N/A	Flare	Traversable RT?	N/A
N/A	Landing Length (in)	N/A	N/A	DWS	Provided?	N/A
N/A	Landing Width (in)	N/A	N/A	DWS	Contrast?	N/A
N/A	Landing Slope (%)	N/A	N/A	DWS	Length (in)	N/A
N/A	Landing X Slope (%)	N/A	N/A	DWS	Full Width?	N/A
N/A	Landing Curb? (Y/N)	N/A	N/A	DWS	Offset (in)	N/A
N/A	Shared Landing?	N/A				
N/A	Gutter Ponding?	N/A	N/A	Gutte	r Slope (%)	N/A
N/A	Gutter Lip Ht (in)	N/A	N/A	Gutte	r X Slope (%)	N/A
N/A	Painted X Walk1?	No	N/A	Paint	ed X Walk2?	No
	X Walk 1 Direction	To W		X Wa	lk 2 Direction	To S
N/A	X Walk 1 Width (in)	N/A	N/A	X Wa	lk 2 Width (in)	N/A
	X Walk 1 Slope (%)	5.8		X Wa	lk 2 Slope (%)	3.7
	X Walk 1 X Slope (%)	3.2		X Wa	lk 2 X Slope (%)	3.7

N/A	Ramp inside XWalk1?	N/A	N/A	Ram	inside XWalk2?	N/A
	Road Slope (%)	0.1	N/A	Clear	Space?	N/A
	Road X Slope (%)	4.2	N/A	Clear	Space to XWalk (in)	N/A
N/A	Any Obstructions?	N/A	N/A	Storn	n Grate/Utility Hazard?	N/A
	Obstruction Type		l	Storn	n Grate/Utility Type	
		N/A				N/A

**ERIE ST** StopSign **LASALLE ST**  **Remove & Replace Curb Ramp With** Two New Directional Ramps or Equivalent.

Total Cost: 3200.00
