Access Compliance Report

Public Rights-of-Way

(Curb Ramps)

Intersection ID: 27855	Main Street: LUNDIN_LINKS_LN	Cross Street: PINE_VALLEY_CLUB_DR	Location: SE
ADA ID: 7DABA1CB579E	Ramp Type: Perp	Initial Pass/Fail: Fail	Overall Compliance: No
Severity Score: 21.25			
Codes/Mitigation Info/Possible Solution		Field Measurements/Component Compliance

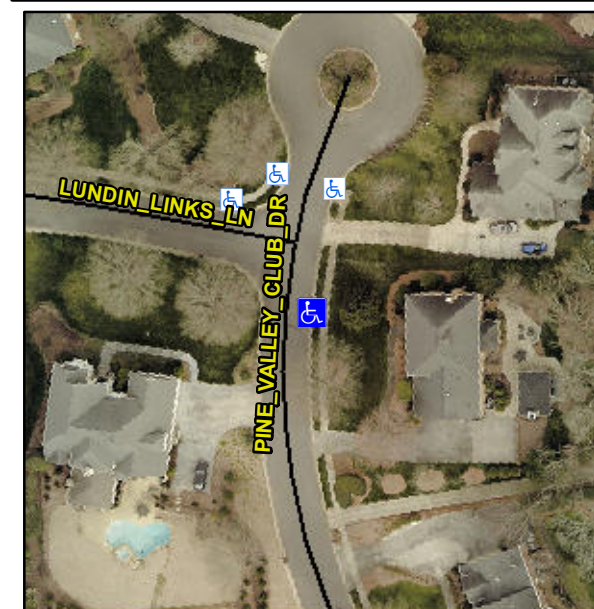
Not Found, R304.5.1, R304.5.3

Compliance	Description	Data	Compliance	Description	Data
N/A	Ramp Length (in)	96.0	Yes	Ramp Slope (%)	7.3
No	Ramp Width (in)	46.5	No	Ramp XSlope (%)	5.2
N/A	Flare Type LT	N/A	N/A	Flare Type RT	N/A
N/A	Flare Slope LT (%)	N/A	N/A	Flare Slope RT (%)	N/A
N/A	Flare Traversable LT?	N/A	N/A	Flare Traversable RT?	N/A
N/A	Landing Length (in)	N/A	N/A	DWS Provided?	N/A
N/A	Landing Width (in)	N/A	N/A	DWS Contrast?	N/A
N/A	Landing Slope (%)	N/A	N/A	DWS Length (in)	N/A
N/A	Landing X Slope (%)	N/A	N/A	DWS Full Width?	N/A
N/A	Landing Curb? (Y/N)	N/A	N/A	DWS Offset (in)	N/A
N/A	Shared Landing?	N/A			
N/A	Gutter Ponding?	N/A	N/A	Gutter Slope (%)	N/A
N/A	Gutter Lip Ht (in)	N/A	N/A	Gutter X Slope (%)	N/A
N/A	Painted X Walk1?	No	N/A	Painted X Walk2?	N/A
	X Walk 1 Direction	To NW		X Walk 2 Direction	N/A
N/A	X Walk 1 Width (in)	N/A	N/A	X Walk 2 Width (in)	N/A
	X Walk 1 Slope (%)	2.9		X Walk 2 Slope (%)	N/A
	X Walk 1 X Slope (%)	0.9		X Walk 2 X Slope (%)	N/A

Possible Solutions:

Remove & Replace Entire Ramp.

Total Cost: \$ 1850.00
