# Access Compliance Report

## Public Rights-of-Way

### (Curb Ramps)

Intersection ID: 10035551	Main Street: REA_RD	Cross Street: N/A	Location: NE
ADA ID: 7DABE9ABCF4D	Ramp Type: Para	Initial Pass/Fail: Fail	Overall Compliance: No
Severity Score: 13.75			
Codes/Mitigation Info/Possible Solution		Field Measurements/Component Compliance

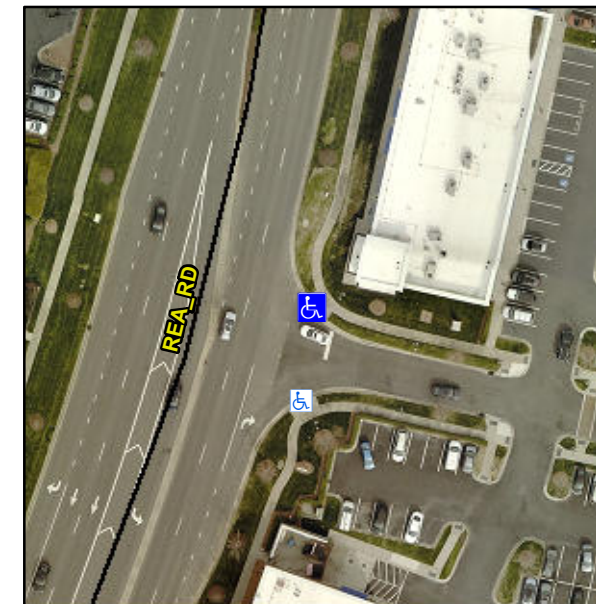
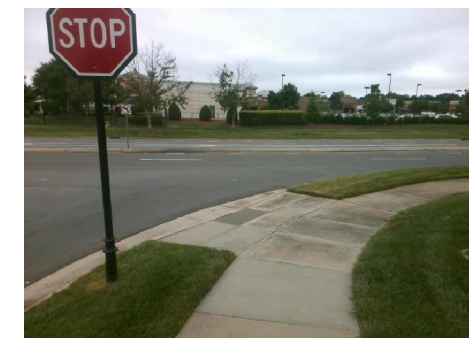
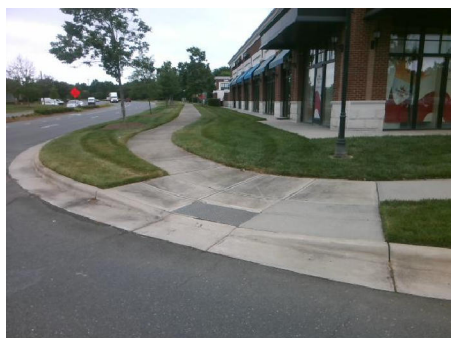
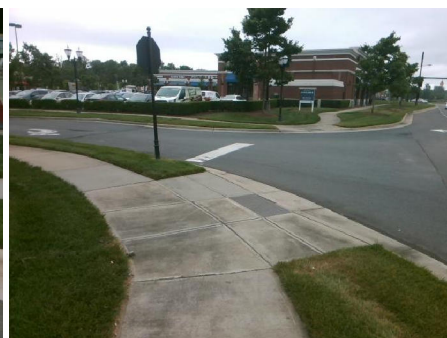
Compliance	Description	Data	Compliance	Description	Data
N/A	Ramp Length LT (in)	51.0	N/A	Ramp Length RT (in)	44.0
Yes	Ramp Width LT (in)	60.0	Yes	Ramp Width RT (in)	60.0
Yes	Ramp Slope LT (%)	5.2	No	Ramp Slope RT (%)	10.5
No	Ramp XSlope LT (%)	2.1	Yes	Ramp XSlope RT (%)	0.2
N/A	Landing Length (in)	N/A	N/A	DWS Provided?	N/A
N/A	Landing Width (in)	N/A	N/A	DWS Contrast?	N/A
N/A	Landing Slope (%)	N/A	N/A	DWS Length (in)	N/A
N/A	Landing X Slope (%)	N/A	N/A	DWS Full Width?	N/A
N/A	Landing Curb? (Y/N)	N/A	N/A	DWS Offset (in)	N/A
N/A	Shared Landing?	N/A			
N/A	Gutter Ponding?	N/A	N/A	Gutter Slope (%)	N/A
N/A	Gutter Lip Ht (in)	N/A	N/A	Gutter X Slope (%)	N/A
N/A	Painted X Walk1?	No	N/A	Painted X Walk2?	N/A
	X Walk 1 Direction	To SW		X Walk 2 Direction	N/A
N/A	X Walk 1 Width (in)	N/A	N/A	X Walk 2 Width (in)	N/A
	X Walk 1 Slope (%)	2.1		X Walk 2 Slope (%)	N/A
	X Walk 1 X Slope (%)	3.0		X Walk 2 X Slope (%)	N/A
N/A	Ramp inside XWalk1?	N/A	N/A	Ramp inside XWalk2?	N/A

Road Slope (%)	N/A	N/A	Clear Space?	N/A
	Road X Slope (%)	N/A	N/A	Clear Space to XWalk (in)	N/A
N/A	Any Obstructions?	N/A	N/A	Storm Grate/Utility Hazard?	N/A
	Obstruction Type			Storm Grate/Utility Type	
		N/A			N/A
			Yes	Surface Condition? (G/P)	Good
			N/A	Curb Slope (%)	14.9

Possible Solutions:

**Remove & Replace Entire Ramp.**
