Access Compliance Report

Public Rights-of-Way

(Curb Ramps)

Intersection ID: 43742	Main Street: RED_CLAY_LN	Cross Street: VANHOY_LN	Location: SW
ADA ID: 7DB242C1257E	Ramp Type: PerpDiag	Initial Pass/Fail: Fail	Overall Compliance: No
		Severity Score: 10

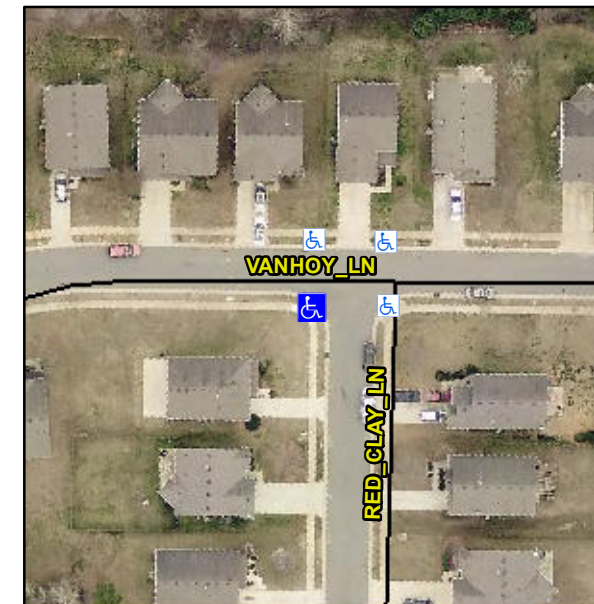
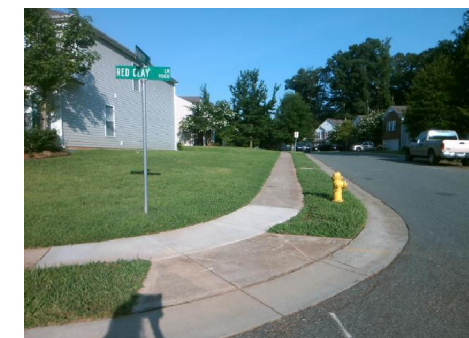
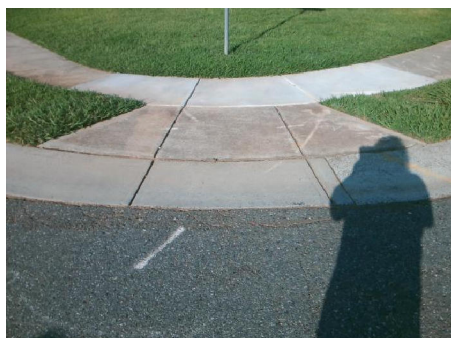
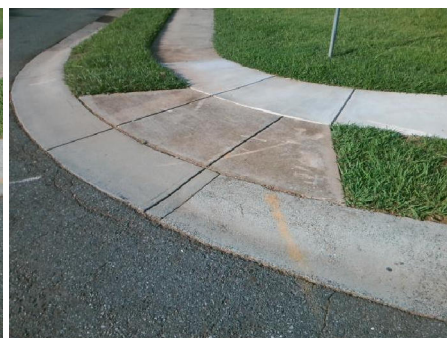
Not Found, R304.5.1, R304.5.3

Compliance	Description	Data	Compliance	Description	Data
N/A	Ramp Length (in)	49.0	Yes	Ramp Slope (%)	8.1
No	Ramp Width (in)	38.0	No	Ramp XSlope (%)	3.3
N/A	Flare Type LT	N/A	N/A	Flare Type RT	N/A
N/A	Flare Slope LT (%)	N/A	N/A	Flare Slope RT (%)	N/A
N/A	Flare Traversable LT?	N/A	N/A	Flare Traversable RT?	N/A
N/A	Landing Length (in)	N/A	N/A	DWS Provided?	N/A
N/A	Landing Width (in)	N/A	N/A	DWS Contrast?	N/A
N/A	Landing Slope (%)	N/A	N/A	DWS Length (in)	N/A
N/A	Landing X Slope (%)	N/A	N/A	DWS Full Width?	N/A
N/A	Landing Curb? (Y/N)	N/A	N/A	DWS Offset (in)	N/A
N/A	Shared Landing?	N/A			
N/A	Gutter Ponding?	N/A	N/A	Gutter Slope (%)	N/A
N/A	Gutter Lip Ht (in)	N/A	N/A	Gutter X Slope (%)	N/A
N/A	Painted X Walk1?	No	N/A	Painted X Walk2?	No
	X Walk 1 Direction	To E		X Walk 2 Direction	To N
N/A	X Walk 1 Width (in)	N/A	N/A	X Walk 2 Width (in)	N/A
	X Walk 1 Slope (%)	6.2		X Walk 2 Slope (%)	4.4
	X Walk 1 X Slope (%)	3.1		X Walk 2 X Slope (%)	6.3

N/A	Ramp inside XWalk1?	N/A	N/A	Ramp inside XWalk2?	N/A
	Road Slope (%)	2.3	N/A	Clear Space?	N/A
	Road X Slope (%)	6.4	N/A	Clear Space to XWalk (in)	N/A
N/A	Any Obstructions?	N/A	N/A	Storm Grate/Utility Hazard?	N/A
	Obstruction Type			Storm Grate/Utility Type	
		N/A			N/A
			Yes	Surface Condition? (G/P)	Good

Remove & Replace Curb Ramp With Two New Directional Ramps or Equivalent.
