# Access Compliance Report

## Public Rights-of-Way

### (Curb Ramps)

| Intersection ID: 23021 | Main Street: OLD_PROVIDENCE_RD | Cross Street: LANDING_VIEW_LN | Location: | N |

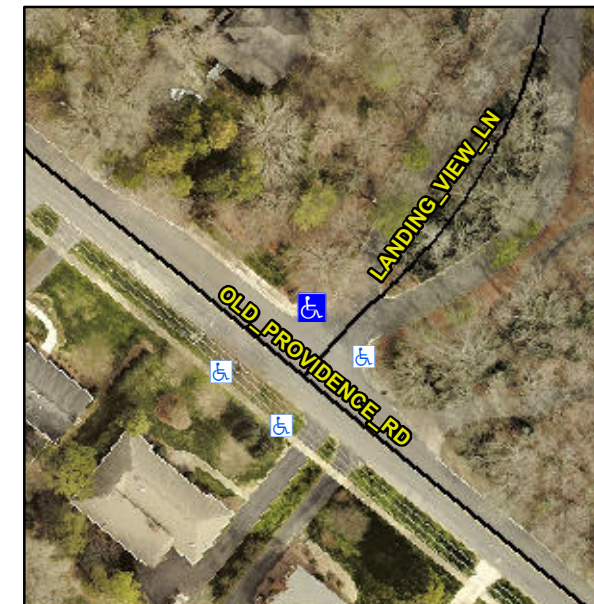
| ADA ID: 7DB33C799A1B | Ramp Type: PerpDiag | Initial Pass/Fail: Fail | Overall Compliance: No | Severity Score: 22.5 |

**Not Found, R304.5.1, R304.2.2, R304.5.3**

| Compliance | Description | Data | Compliance | Description | Data |
|---|---|---|---|---|---|
| N/A | Ramp Length (in) | 47.5 | No | Ramp Slope (%) | 10.4 |
| No | Ramp Width (in) | 44.0 | No | Ramp XSlope (%) | 2.3 |

**Remove & Replace Curb Ramp With Two New Directional Ramps or Equivalent.**
