# Access Compliance Report

## Public Rights-of-Way

### (Curb Ramps)

| Intersection ID: 10013834 | Main Street: IKEA_BV | Cross Street: N/A | Location: NW |

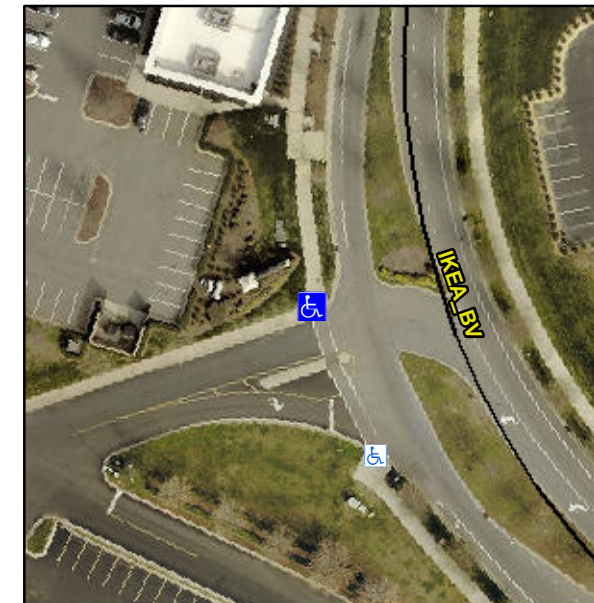
**Not Found, R304.2.2**

| Compliance | Description | Data | Compliance | Description | Data |
|---|---|---|---|---|---|
| N/A | Ramp Length (in) | 117.0 | No | Ramp Slope (%) | 9.2 |
| Yes | Ramp Width (in) | 48.0 | Yes | Ramp XSlope (%) | 1.2 |

**Remove & Replace Curb Ramp With Two New Directional Ramps or Equivalent.**
