Access Compliance Report

Public Rights-of-Way

(Curb Ramps)

| Intersection ID: 17341 | Main Street: AUTUMN_RAIN_LN | Cross Street: SHADOW_ELM_DR | Location: SE |

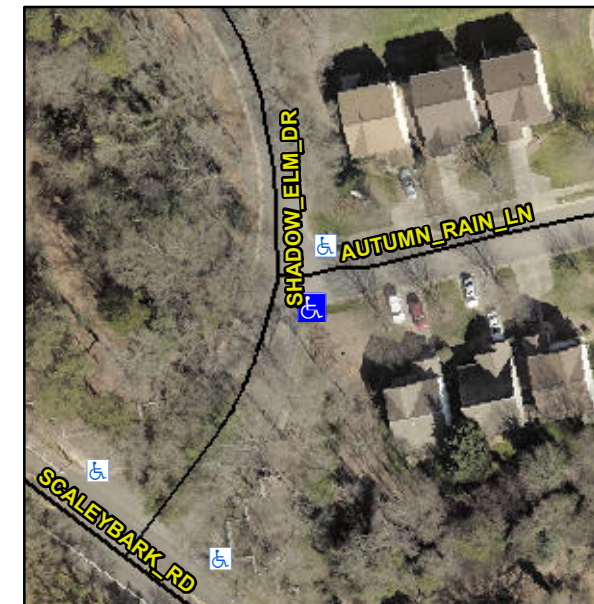
| ADA ID: 7DBABD9BD819 | Ramp Type: PerpDiag | Initial Pass/Fail: Fail | Overall Compliance: No |
| Severity Score: 13.75 | | | |

Not Found, R304.2.2, R304.5.3

| Compliance | Description | Data | Compliance | Description | Data |
|---|---|---|---|---|---|
| N/A | Ramp Length (in) | 48.0 | No | Ramp Slope (%) | 10.8 |
| Yes | Ramp Width (in) | 48.0 | No | Ramp XSlope (%) | 2.4 |

Remove & Replace Curb Ramp With Two New Directional Ramps or Equivalent.
