Access Compliance Report

Public Rights-of-Way

(Curb Ramps)

| Intersection ID: 3425 | Main Street: ISLAND_COVE_LN | Cross Street: OVERLOOK_MOUNTAIN_DR | Location: NE |

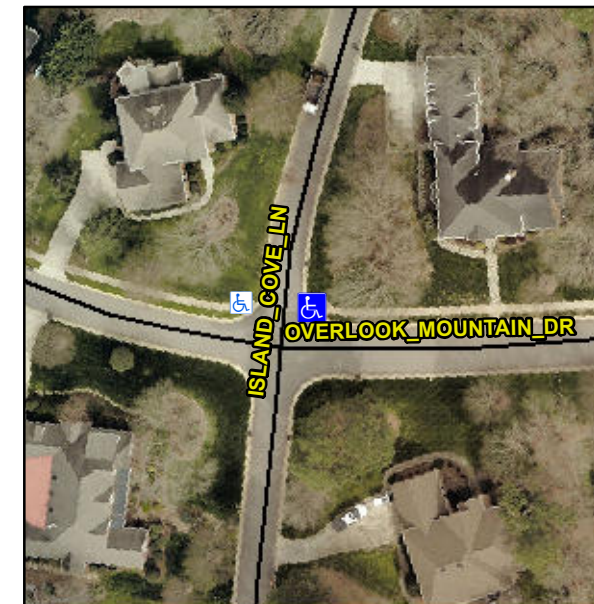
**Not Found, R304.2.1, R304.2.2-Perp,
R304.3.2-Para, R304.5.3, R305.2,
R304.5.4**

| Compliance | Description | Data | Compliance | Description | Data |
|---|---|---|---|---|---|
| No | Landing Length (in) | N/A | Yes | DWS Provided? | Yes |
| No | Landing Width (in) | N/A | Yes | DWS Contrast? | Yes |
| No | Landing Slope (%) | N/A | Yes | DWS Length (in) | 24.0 |
| No | Landing X Slope (%) | N/A | Yes | DWS Full Width? | Yes |
| N/A | Landing Curb? (Y/N) | No | No | DWS Offset (in) | 3.0 |
| Yes | Gutter Ponding? | No | No | Gutter Slope (%) | 6.5 |
| Yes | Gutter Lip Ht (in) | 0.0 | No | Gutter X Slope (%) | 2.1 |

**Remove & Replace Entire Ramp.
Remove & Replace Gutter.**
