# Access Compliance Report

## Public Rights-of-Way

### (Curb Ramps)

| Intersection ID: 17486 | Main Street: SELWYN_AV | Cross Street: STERLING_RD | Location: SE |

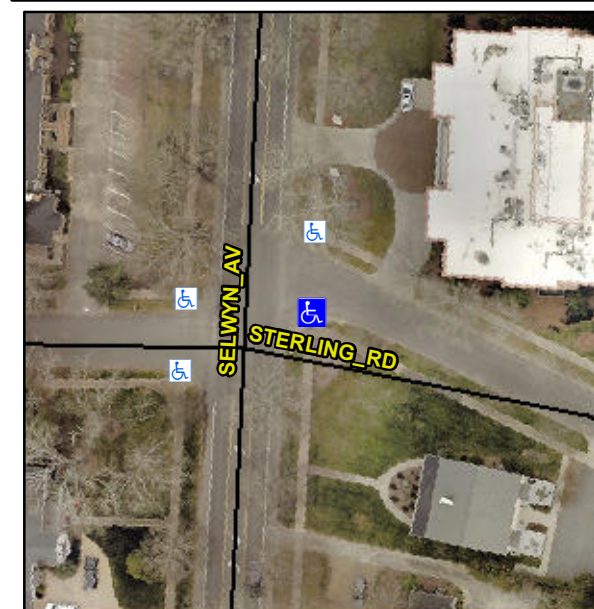
| ADA ID: 7DBECF9BEB57 | Ramp Type: PerpDiag | Initial Pass/Fail: Fail | Overall Compliance: No |
| Severity Score: 12.5 | | | |

**Not Found, R304.2.2**

| Compliance | Description | Data | Compliance | Description | Data |
|---|---|---|---|---|---|
| N/A | Ramp Length (in) | 96.0 | No | Ramp Slope (%) | 9.3 |
| Yes | Ramp Width (in) | 72.0 | Yes | Ramp XSlope (%) | 1.4 |

**Remove & Replace Curb Ramp With Two New Directional Ramps or Equivalent.**

Total Cost: \$ 3200.00
