Access Compliance Report

Public Rights-of-Way

(Curb Ramps)

Intersection ID: 4194	Main Street: COLVARD_PARK_WY	Cross Street: MALLARD_CREEK_RD	Location: NW
ADA ID: 7DC0445B3EBF	Ramp Type: Perp	Initial Pass/Fail: Fail	Overall Compliance: No
Severity Score: 33.75			
Codes/Mitigation Info/Possible Solution		Field Measurements/Component Compliance

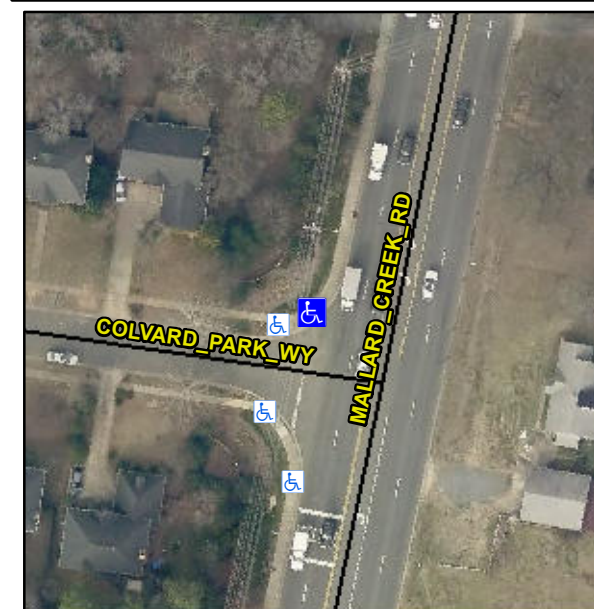
Compliance	Description	Data	Compliance	Description	Data
N/A	Ramp Length (in)	61.5	No	Ramp Slope (%)	13.0
No	Ramp Width (in)	43.0	Yes	Ramp XSlope (%)	1.7
N/A	Flare Type LT	N/A	N/A	Flare Type RT	N/A
N/A	Flare Slope LT (%)	N/A	N/A	Flare Slope RT (%)	N/A
N/A	Flare Traversable LT?	N/A	N/A	Flare Traversable RT?	N/A
N/A	Landing Length (in)	N/A	N/A	DWS Provided?	N/A
N/A	Landing Width (in)	N/A	N/A	DWS Contrast?	N/A
N/A	Landing Slope (%)	N/A	N/A	DWS Length (in)	N/A
N/A	Landing X Slope (%)	N/A	N/A	DWS Full Width?	N/A
N/A	Landing Curb? (Y/N)	N/A	N/A	DWS Offset (in)	N/A
N/A	Shared Landing?	N/A			
N/A	Gutter Ponding?	N/A	N/A	Gutter Slope (%)	N/A
N/A	Gutter Lip Ht (in)	N/A	N/A	Gutter X Slope (%)	N/A
N/A	Painted X Walk1?	No	N/A	Painted X Walk2?	N/A
	X Walk 1 Direction	To E		X Walk 2 Direction	N/A
N/A	X Walk 1 Width (in)	N/A	N/A	X Walk 2 Width (in)	N/A
	X Walk 1 Slope (%)	0.3		X Walk 2 Slope (%)	N/A
	X Walk 1 X Slope (%)	1.4		X Walk 2 X Slope (%)	N/A

N/A	Ramp inside XWalk1?	N/A	N/A	Ramp inside XWalk2?	N/A
	Road Slope (%)	N/A	N/A	Clear Space?	N/A
	Road X Slope (%)	N/A	N/A	Clear Space to XWalk (in)	N/A
N/A	Any Obstructions?	N/A	N/A	Storm Grate/Utility Hazard?	N/A
	Obstruction Type			Storm Grate/Utility Type	
		N/A			N/A
			Yes	Surface Condition? (G/P)	Good

Possible Solutions:

Remove & Replace Entire Ramp.
