Access Compliance Report Public Rights-of-Way (Curb Ramps)

Intersection ID: 49689 Main Street: ALEXANDER_ALLEY_DR Cross Street: SHARON_HILLS_RD Location: N

ADA ID: 7DD64F8434C4 Ramp Type: PerpDiag Initial Pass/Fail: Pass Overall Compliance: No Severity Score: 2.75

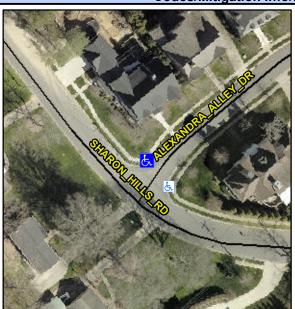
Comp	Compliance Description		Compliance		Description	Data
N/A	Ramp Length (in)	49.0	Yes	Ramp	Slope (%)	7.5
Yes	Ramp Width (in)	48.0	No	Ramp	XSlope (%)	4.8
N/A	Flare Type LT	Sloped	N/A	Flare	Type RT	N/A
N/A	Flare Slope LT (%)	0.9	No	Flare	Slope RT (%)	10.6
N/A	Flare Traversable LT?	Yes	N/A	Flare	Traversable RT?	Yes
Yes	Landing Length (in)	49.0	Yes	DWS	Provided?	Yes
Yes	Landing Width (in)	48.0	Yes	DWS	Contrast?	Yes
No	Landing Slope (%)	2.2	Yes	DWS	Length (in)	24.5
No	Landing X Slope (%)	5.3	Yes	DWS	Full Width?	Yes
N/A	Landing Curb? (Y/N)	No	Yes	DWS	Offset (in)	0.0
N/A	Shared Landing?	No				
Yes	Gutter Ponding?	No	Yes	Gutte	r Slope (%)	0.4
Yes	Gutter Lip Ht (in)	0.0	No	Gutte	r X Slope (%)	3.3
N/A	Painted X Walk1?	No	N/A	Paint	ed X Walk2?	No
	X Walk 1 Direction	To SW		X Wa	lk 2 Direction	To SE
N/A	X Walk 1 Width (in)	N/A	N/A	X Wa	lk 2 Width (in)	N/A
	X Walk 1 Slope (%)	4.1		X Wa	lk 2 Slope (%)	2.1
	X Walk 1 X Slope (%)	0.8		X Wa	lk 2 X Slope (%)	3.2

N/A	Ramp inside XWalk1?	N/A	N/A	Ram	inside XWalk2?	N/A
	Road Slope (%)	3.8	N/A	Clear	Space?	Yes
	Road X Slope (%)	2.6	N/A	Clear	Space to XWalk (in)	N/A
Yes	Any Obstructions?	No	Yes	Storn	n Grate/Utility Hazard?	No
	Obstruction Type			Storn	n Grate/Utility Type

SHARON HILLS RD None ALEXANDER ALLEY DR StopSign Remove & Replace Curb Ramp With Two New Directional Ramps or Equivalent. Remove & Replace Gutter.

PROW/ADA:
Not Found, R304.5.3, R304.2.2-Perp, R304.3.2-Para, R304.2.3
