Access Compliance Report

Public Rights-of-Way

(Curb Ramps)

| Intersection ID: 28108 | Main Street: BERITSTRASSE_CT | Cross Street: DARBY_CHASE_DR | Location: SE |

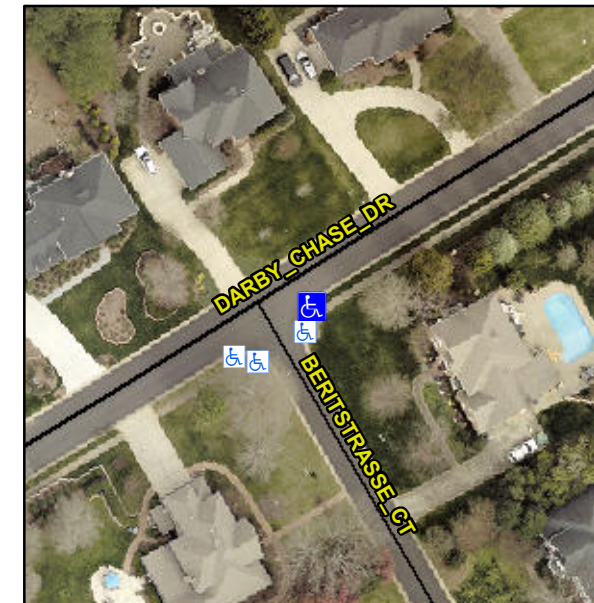
| ADA ID: 7DDA692FD89E | Ramp Type: Perp | Initial Pass/Fail: Fail | Overall Compliance: No |

Not Found, R302.7

| Compliance | Description | Data | Compliance | Description | Data |
|---|---|---|---|---|---|
| | | No | | Surface Condition? (G/P) | Poor |

Remove & Replace Entire Ramp.
